NATIONAL AERONAUTICS AND SPACE ADMINISTRATION

MISSION OPERATIONS REPORT

APOLLO 13

APRIL 28, 1970

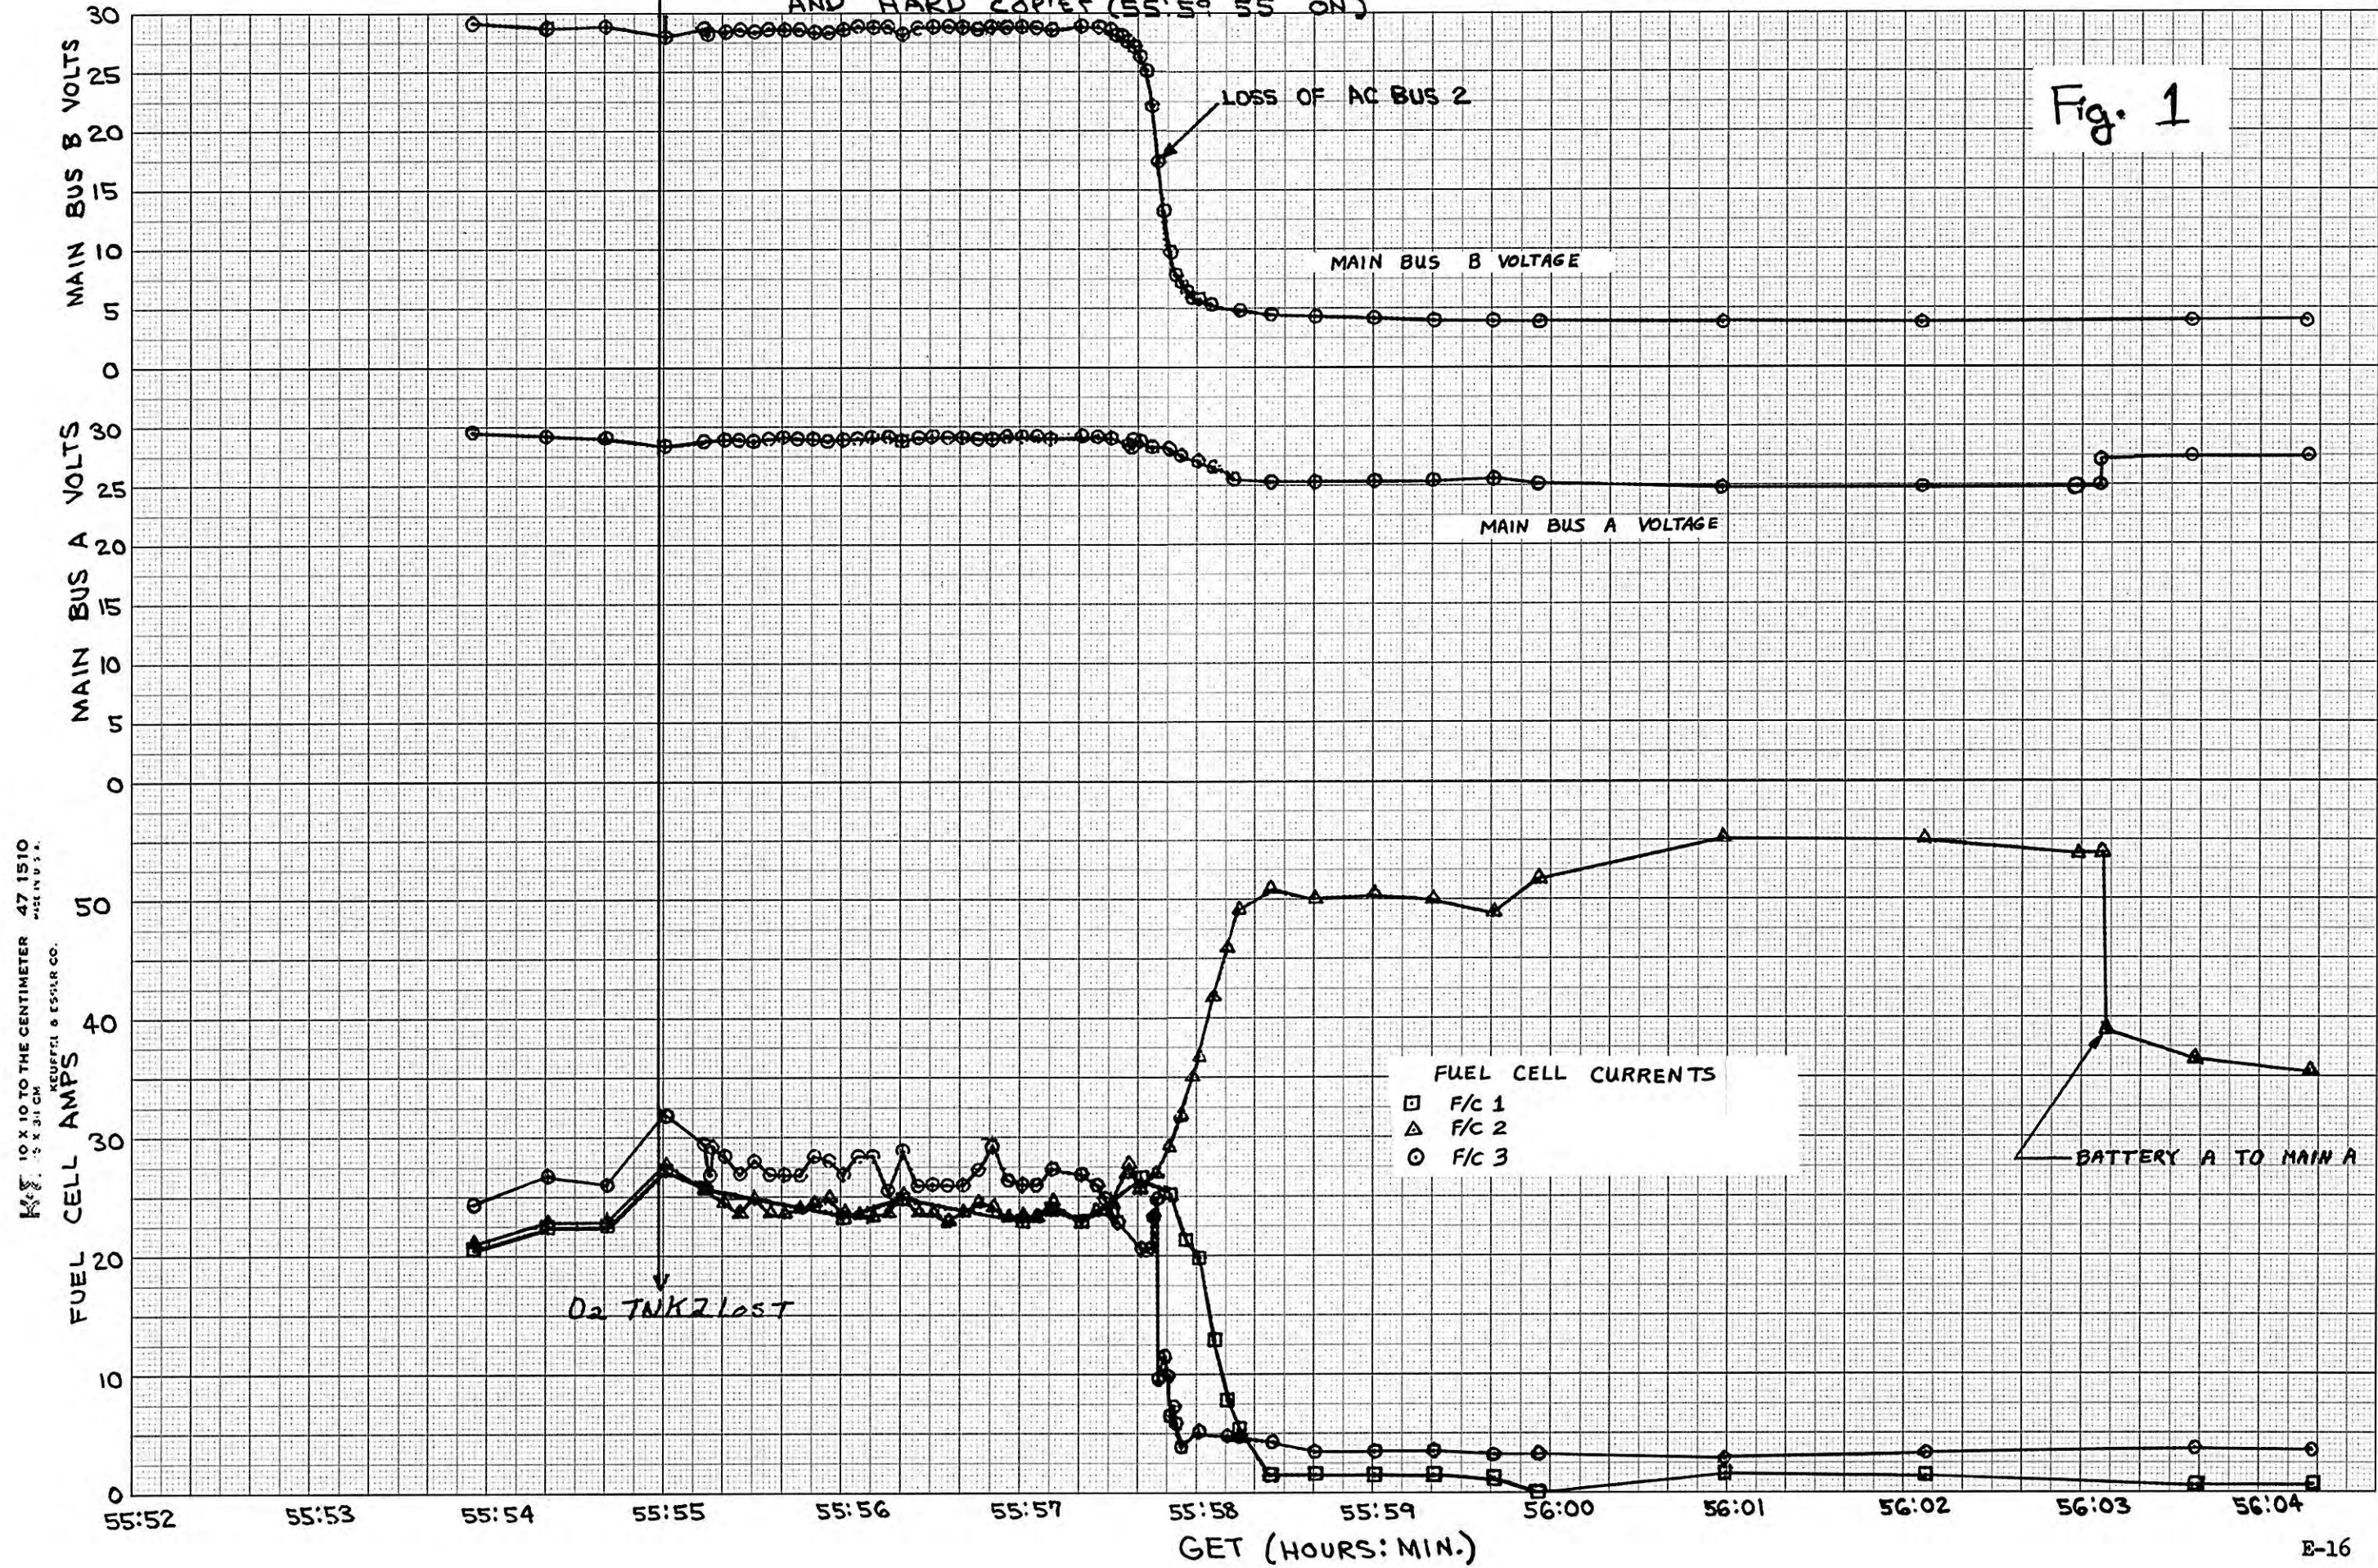
Fig. 1

Plotted From DLOGS (55:53:55 to 55:59:55)  
AND HARD COPIES (55:59:55 ON)

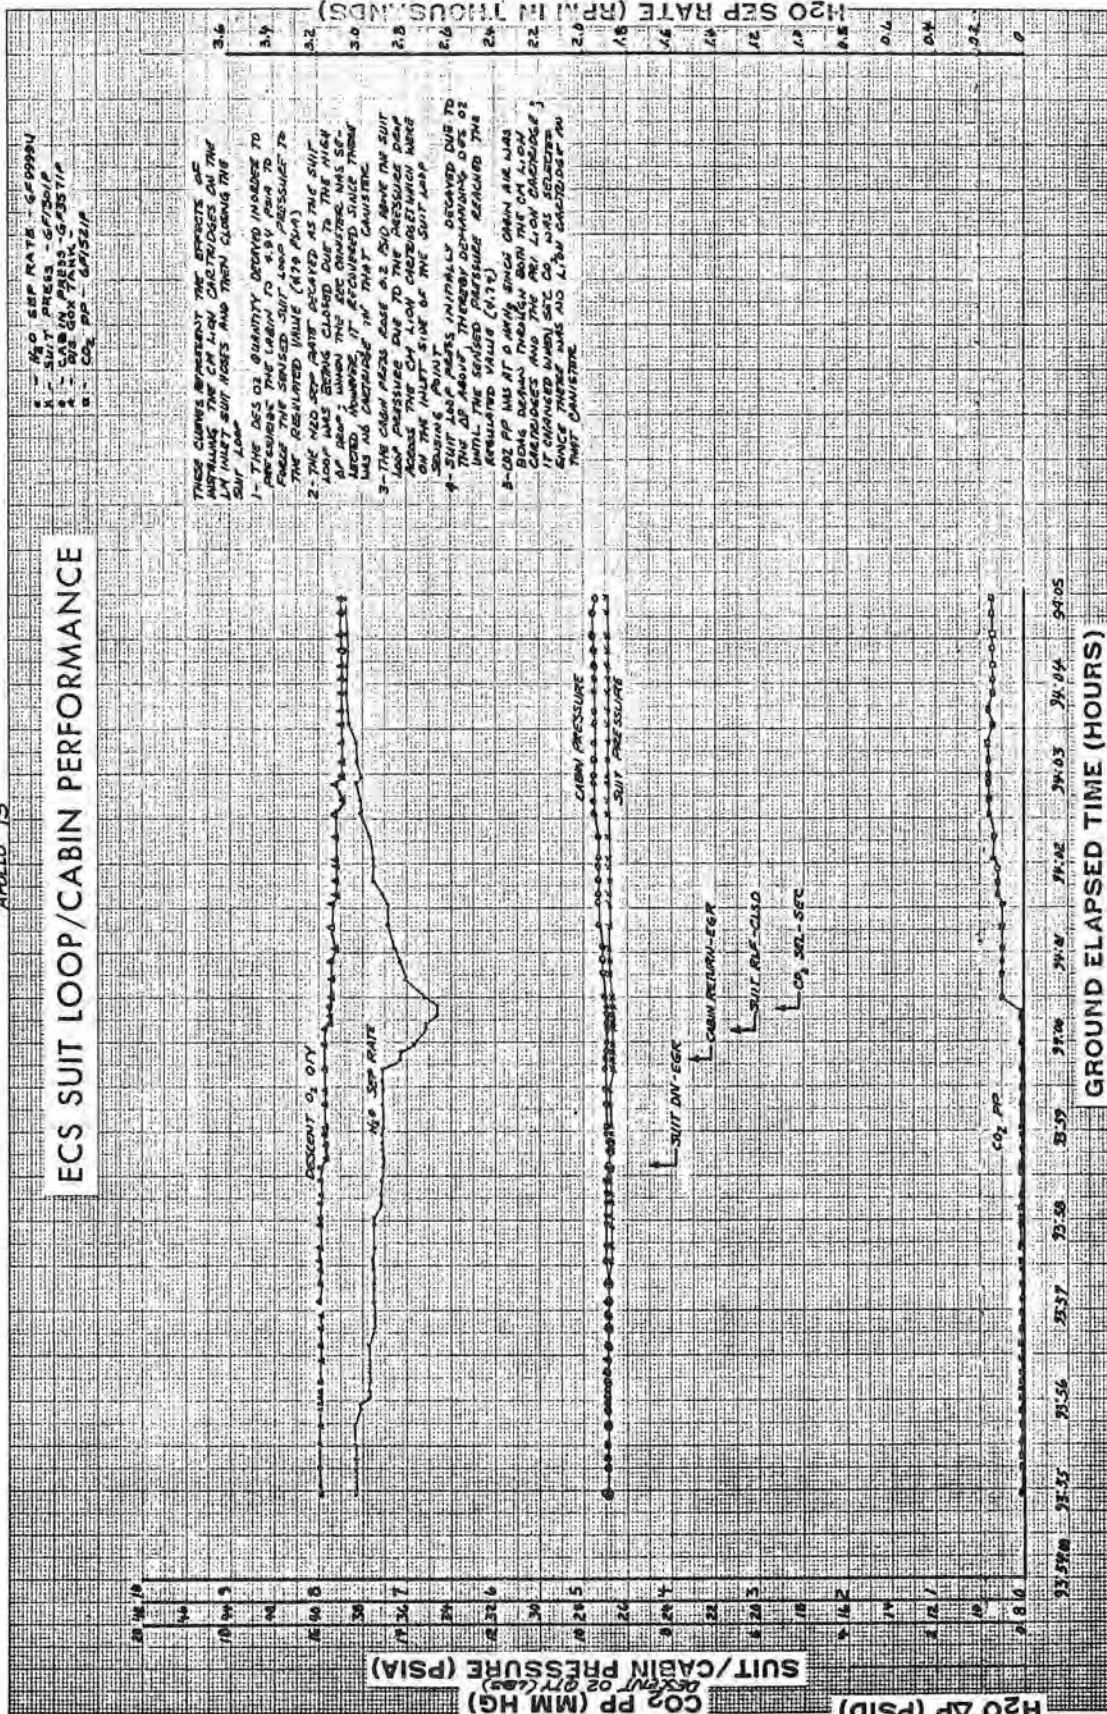
THESE CURVES REPRESENT THE EFFECTS OF  
 MISTRANS THE CH LOW CARTRIDGES ON THE  
 LM INLET SUIT HOSES AND THEN CLOSING THE  
 SUIT LOOP

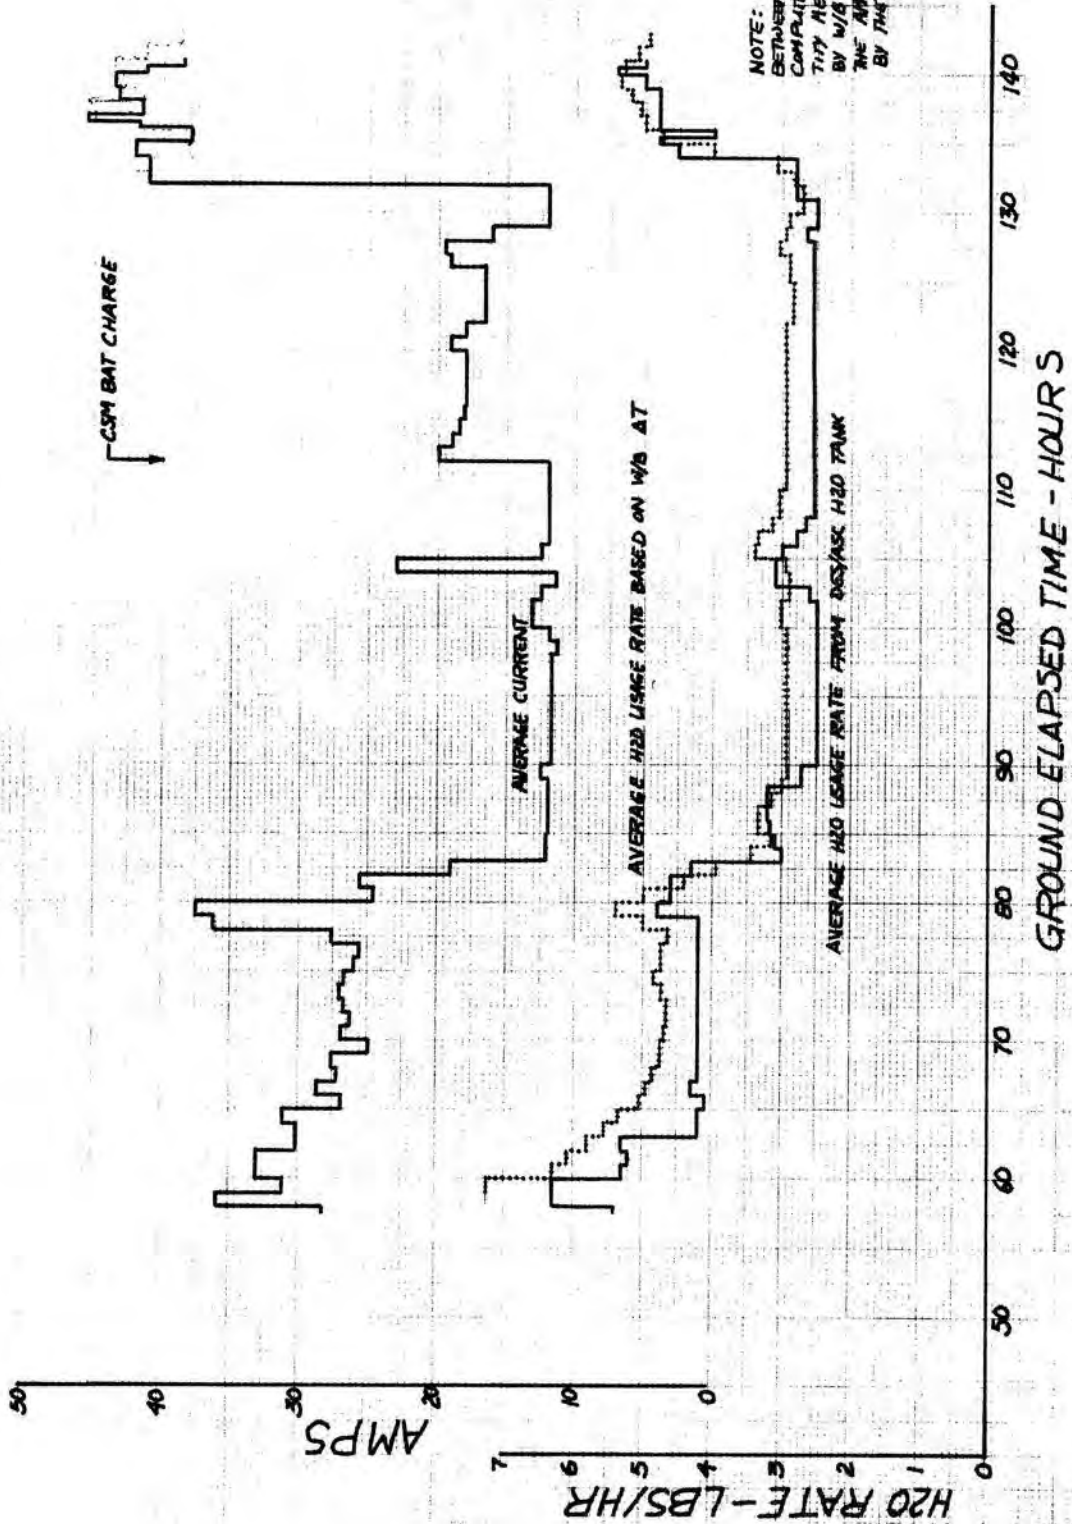
Figure 5

The comparison plot of water usage rate and battery current rate clearly demonstrates the dependency of the former on the latter. Additionally, the water boiled as indicated by the  $\Delta T$  across the sublimator is plotted to demonstrate that the water separators contributed water to the sublimator. Under the steady state portions of the mission, the additional water provided by the separators was 0.4 to 0.45 lbs/hr. The total water consumption rate was 2.95 lbs/hr for a selected period of several hours, 1.35 lbs/hr of which was due to electrical loads, about 1.17 of which was due to crew matabolic and LiOH reaction loads (based on an average of 1220 BUT/hr from the crew from the O<sub>2</sub> consumption) and the remainder (0.43 lbs/hr) due to structural heat loads.

WATER USAGE RATE AND BATTERY CURRENT VERSUS TIME  
 APOLLO 13

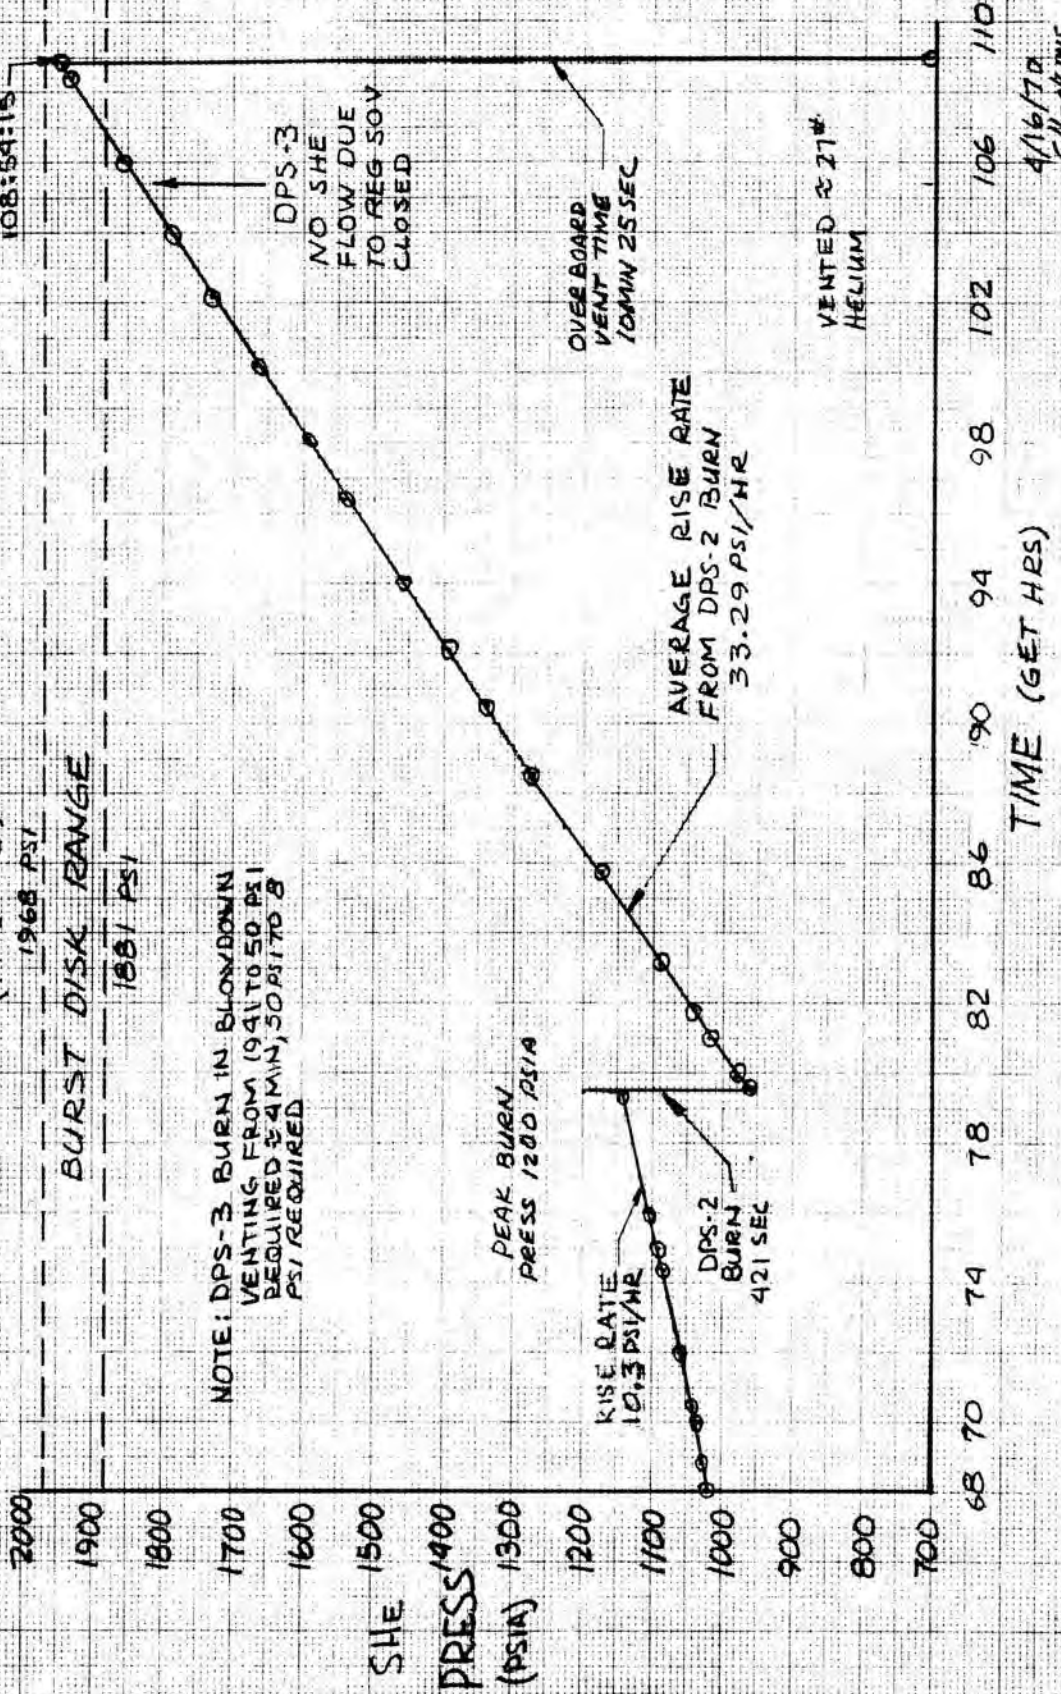
# APOLLO 13 LM-7 SHE BURST DISK RUPTURE

BURST DISK RUPTURE  
108:54:10 GET  
PRESS APPROX. 1940 PSI

NOTE: APPROX 27.5% HE IN SHE  
TANK AT TIME OF DISK RUPTURE
