NATIONAL AERONAUTICS AND SPACE ADMINISTRATION

MISSION OPERATIONS REPORT

APOLLO 13

APRIL 28, 1970

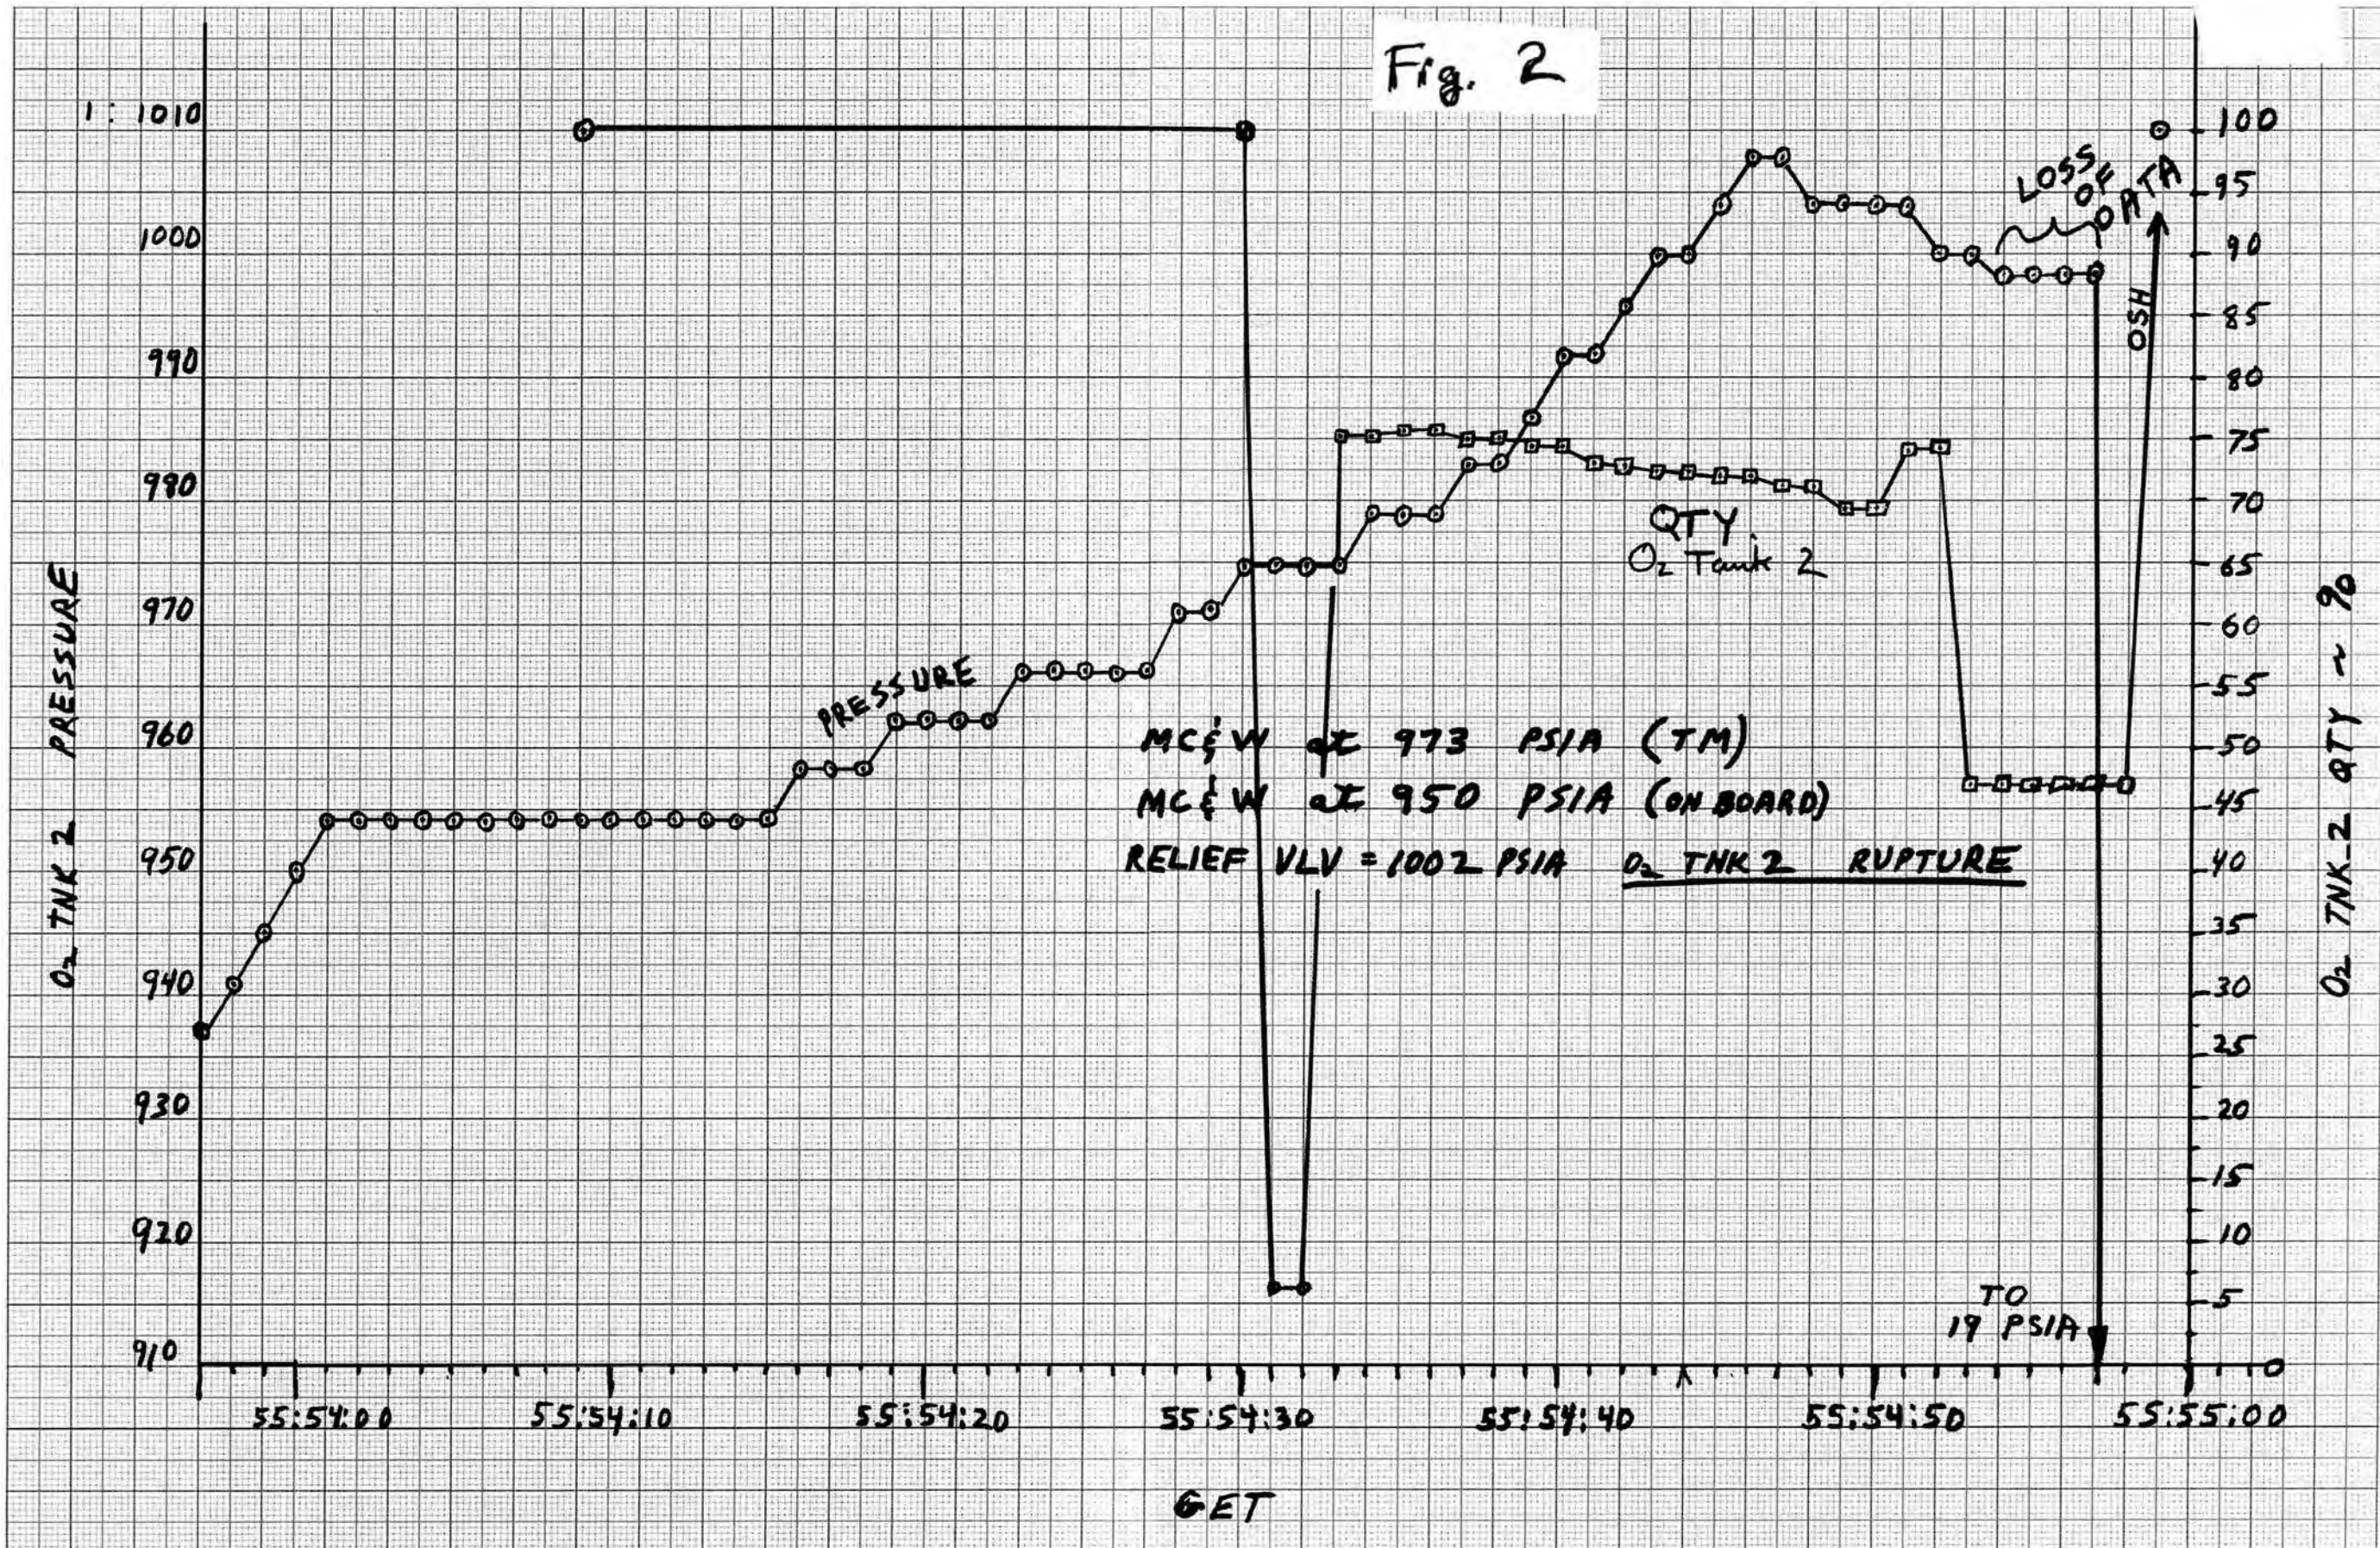
Fig. 3

55:53:35 O2 Tank 2 pressure starts to increase rapidly while O2 Tank 1 remains normal. Tank 2 pressure at this time was 891 psi. (See Fig. 3)

- 55:54:28 O2 Tank 2 pressure passed through 973 psi with no Hi Cryo Press MC and W. H2 Tank 2 was below its low pressure limit. O2 Tank 2 Qty dropped from 101.17 percent down to 6.5 percent for 3 seconds and the temperature started increasing from -190° F. (See Fig. 3.)

- 55:54:52 O2 Tank 2 press dropped to 998 psi, indicating possible pressure relieving. Temp had increased to max of -153° F, then dropped off scale low (-329° F.). (See Fig. 3.)

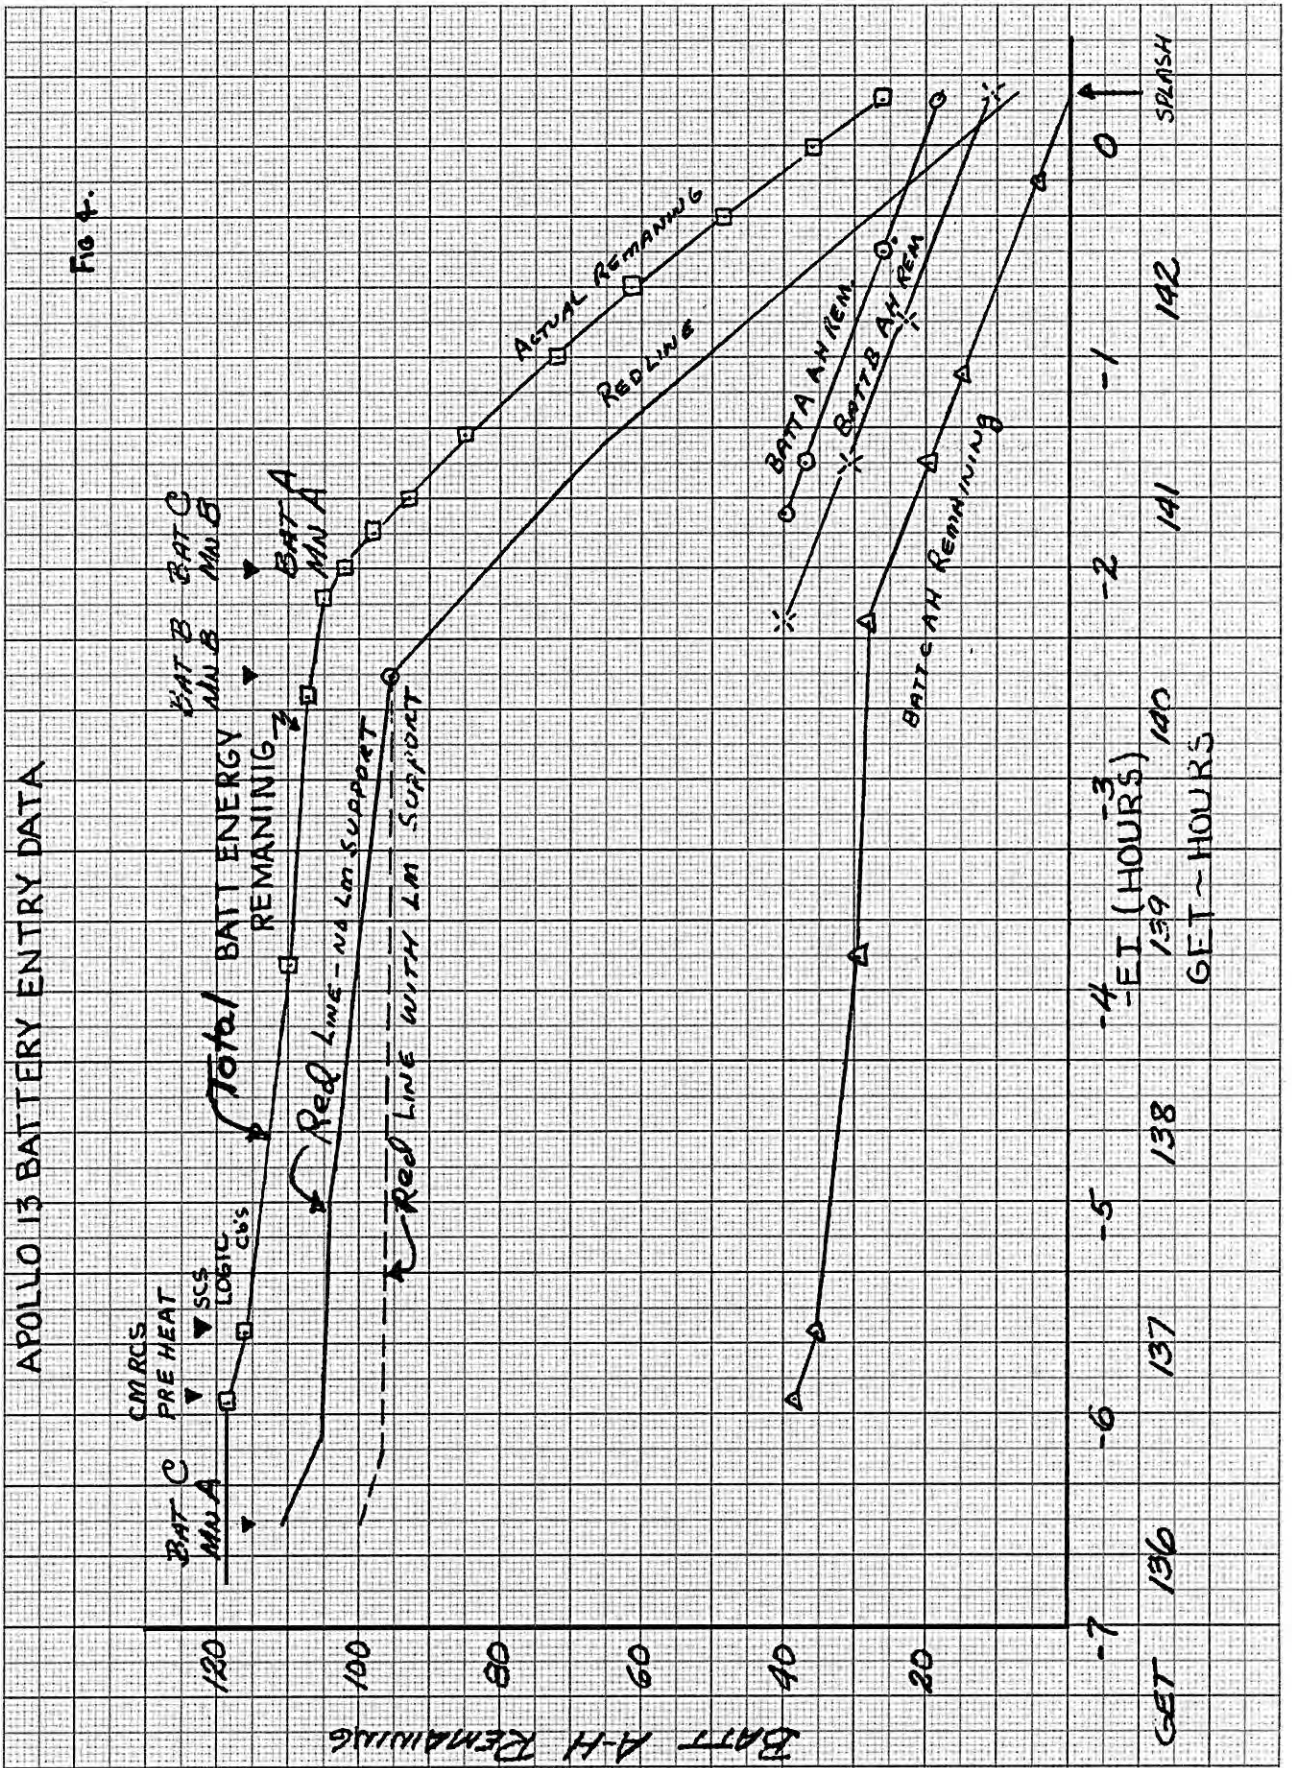
Fig 4.

The entry sequence timeline was then eventually moved back to EI -6+30. The primary plan of operation was to have the crew ingress the CM at EI -6 1/2 hours and use IM power to support Main bus B loads and battery C to support Main bus A loads, during CM RCS preheat and up to EI -2 1/2 hours where the CM went full internal. All possible loads during this time period were placed on Main B only (IM power). A contingency plan of operation using less power was also available, but not uplinked, in the event that the IM was unable to supply the CM with power during the entry phase (see figure 4 for redlines).

As can be noted from Figure 4, the actual battery energy margin was approximately 20 amp-hours above the redline at all times. Battery C was depleted, as predicted, prior to splash, thus leaving two good batteries (A and B) to support ELS sequential functions and Main Bus A and B loads. Figure 5 shows the load profile as predicted with real time loads superimposed on the predicted graph. It had been predicted that the Battery VI characteristic would be degraded due to low temperatures. This concern turned out to be invalid, as the Battery VI characteristic was comparable to previous flights with Main A = 29.2 VDC and Main B = 29.2 VDC for a total spacecraft load of 38 amps on two batteries. In the event that the loads had been higher than predicted, and the battery energy redline violated, the following equipment was planned to have

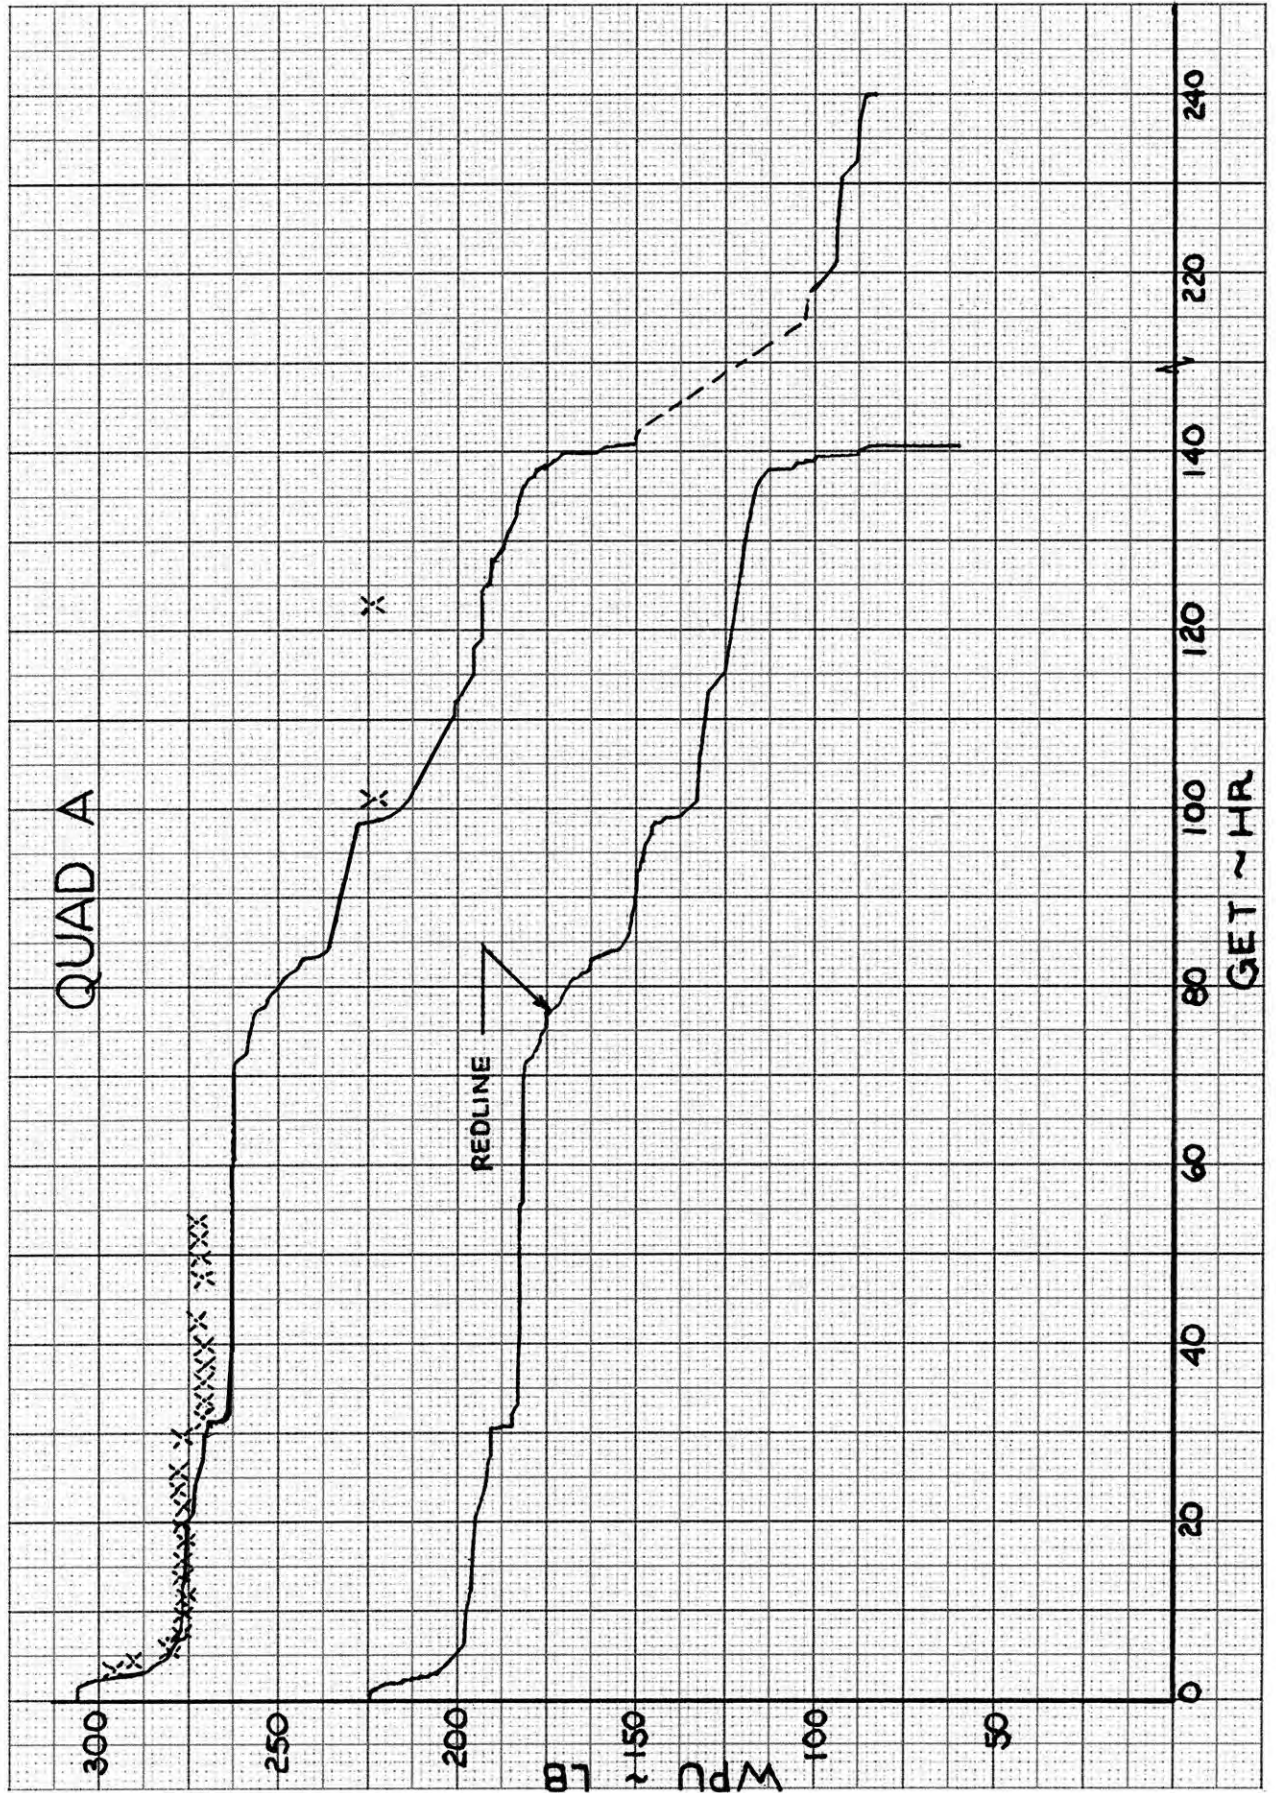
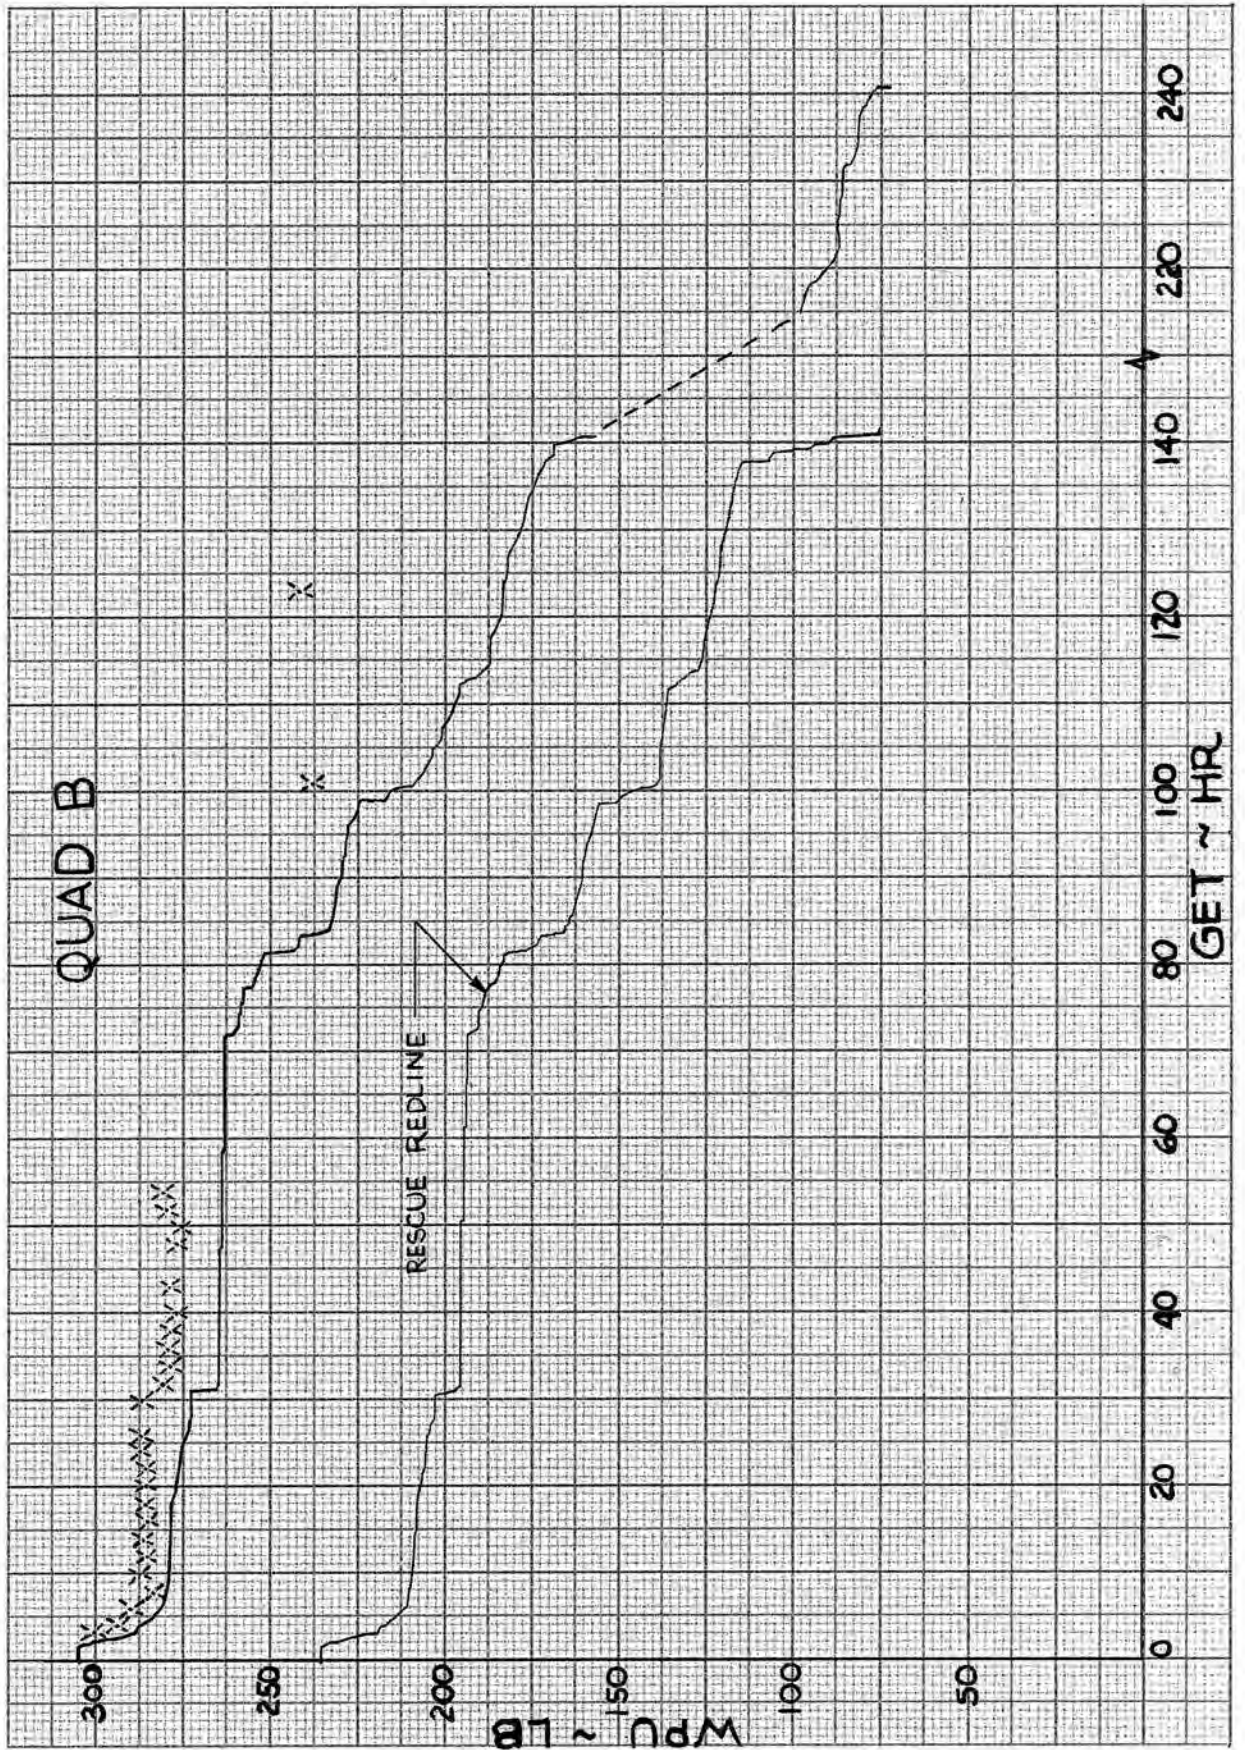
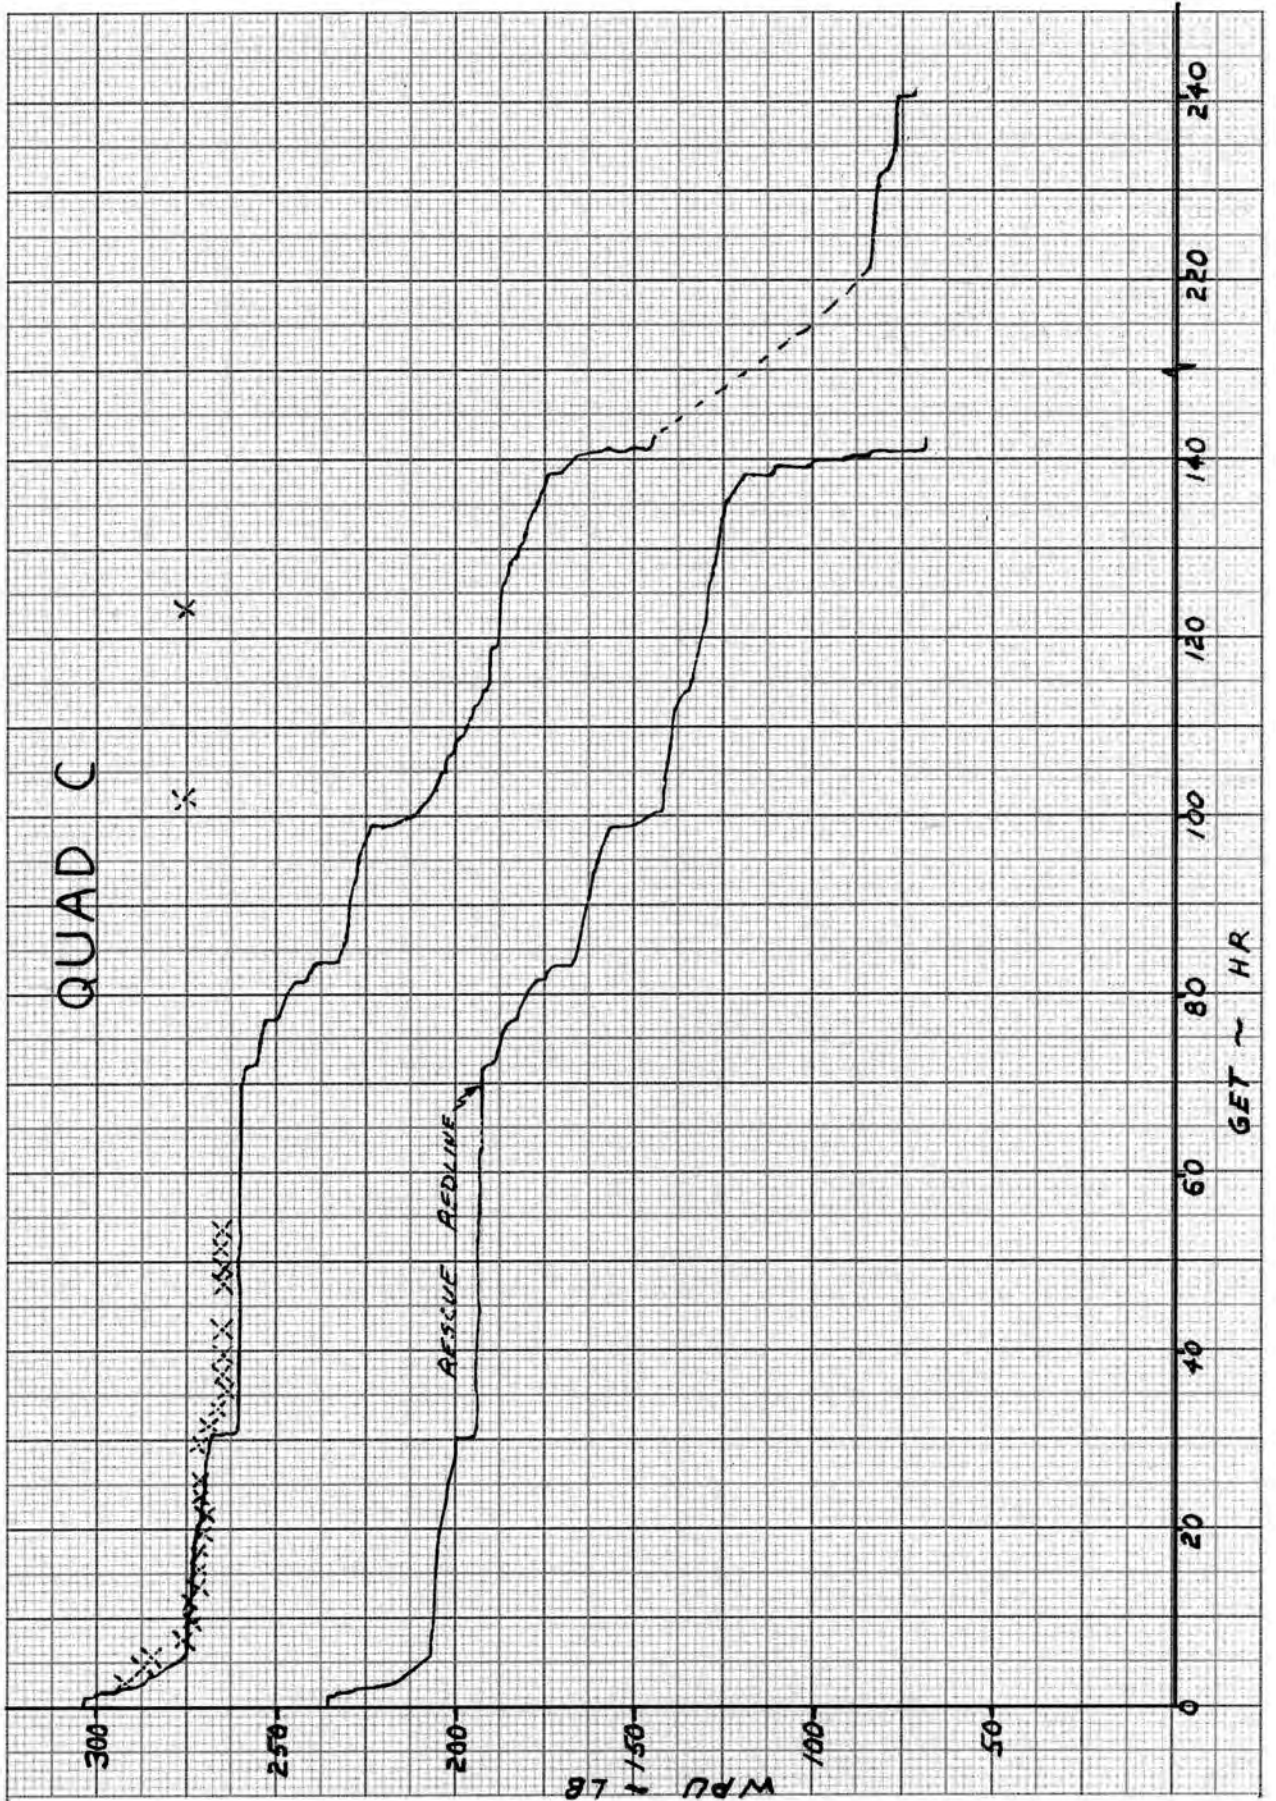
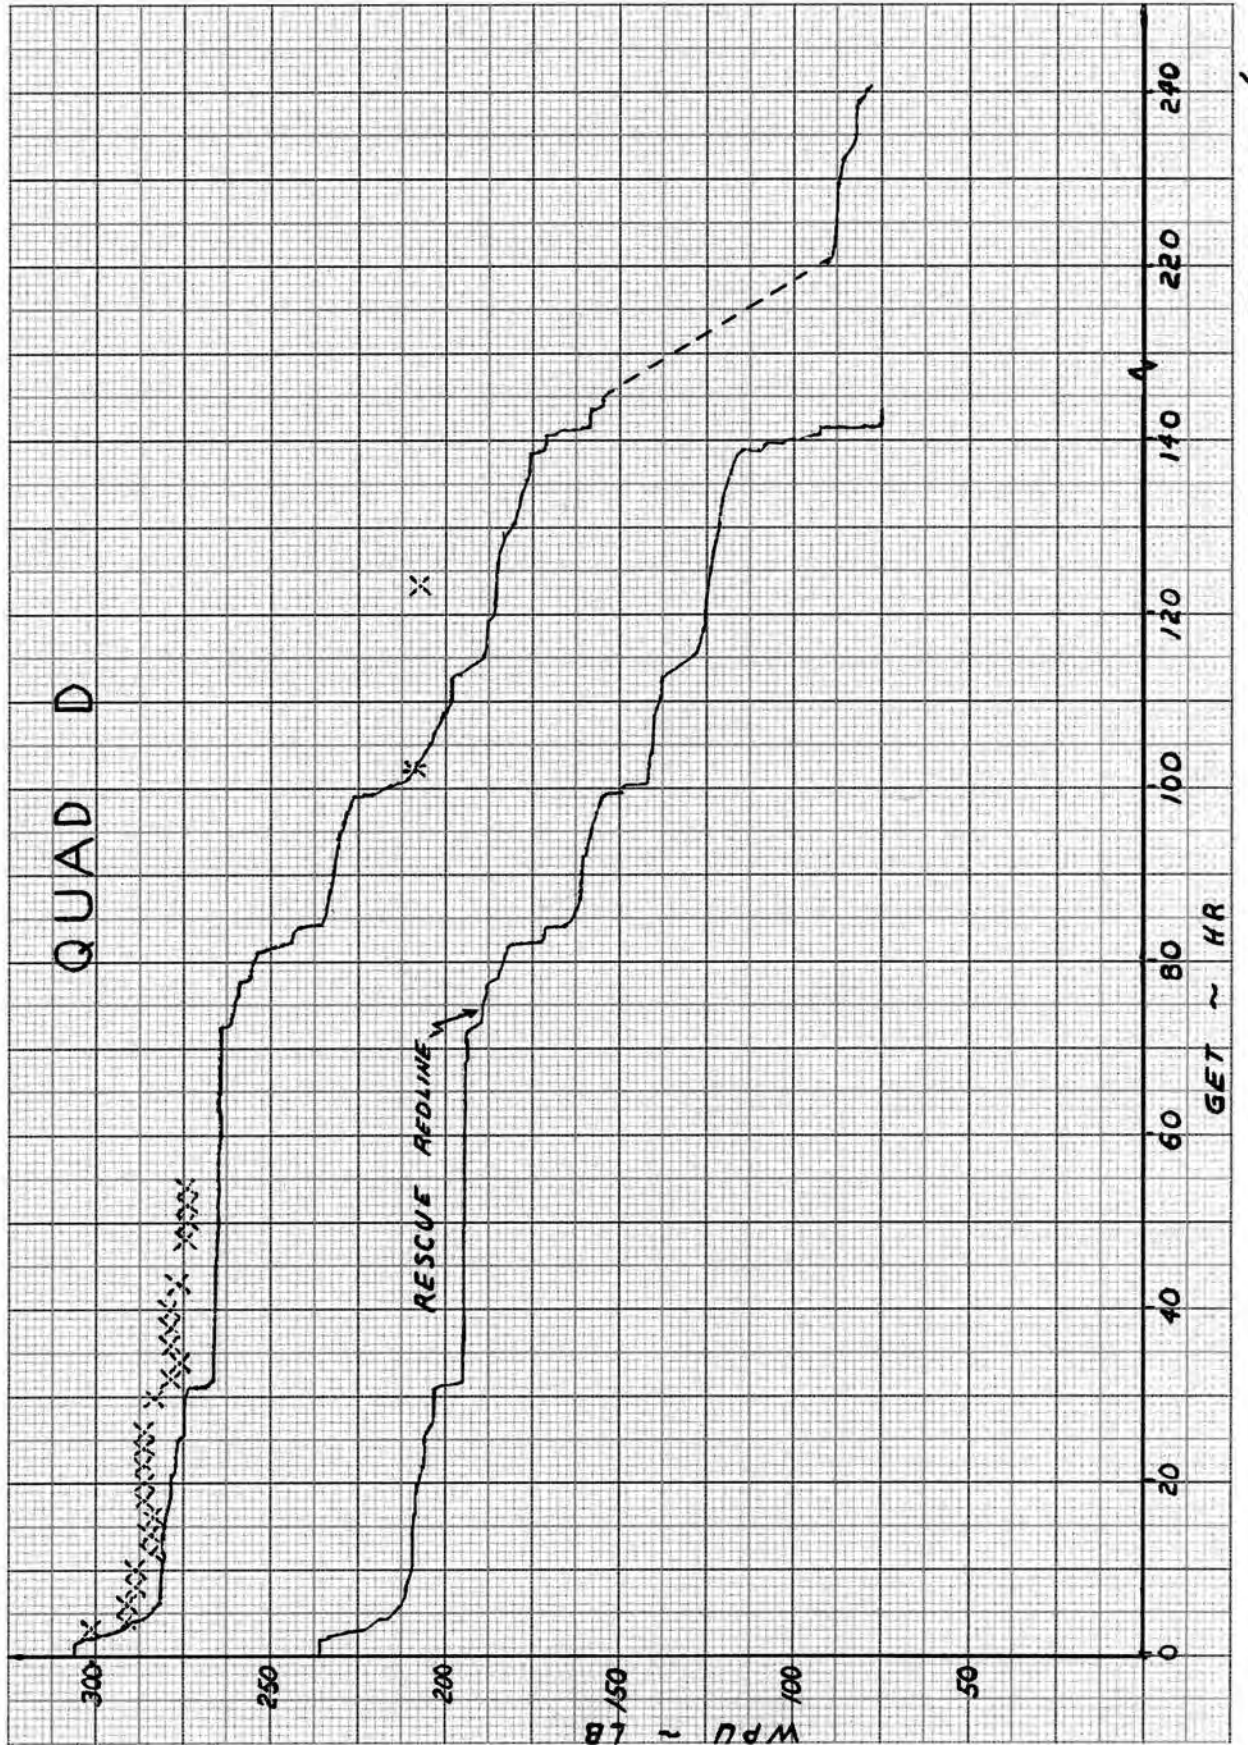
Subsequently, the crew reported continued trouble damping the vehicle rates. This was because the DAP had A/C roll selected and the crew had turned off thruster A1. With this configuration  $\pm$  Yaw, -Pitch and -Roll was the only control available. There was at this time no indication of Quad C propellant usage forcing the conclusion that either the fuel and oxidizer primary propellant isolation valves were closed or that Quad C was inoperable because of damage. Since both the propellant valves and their talkback indicators required MNB power, the anomaly was left open. The crew subsequently selected B/D roll in the DAP and selected MNA on the RCS jet selects to regain auto control. Figures 1 through 4 show the SMRCS propellant usage on this flight.

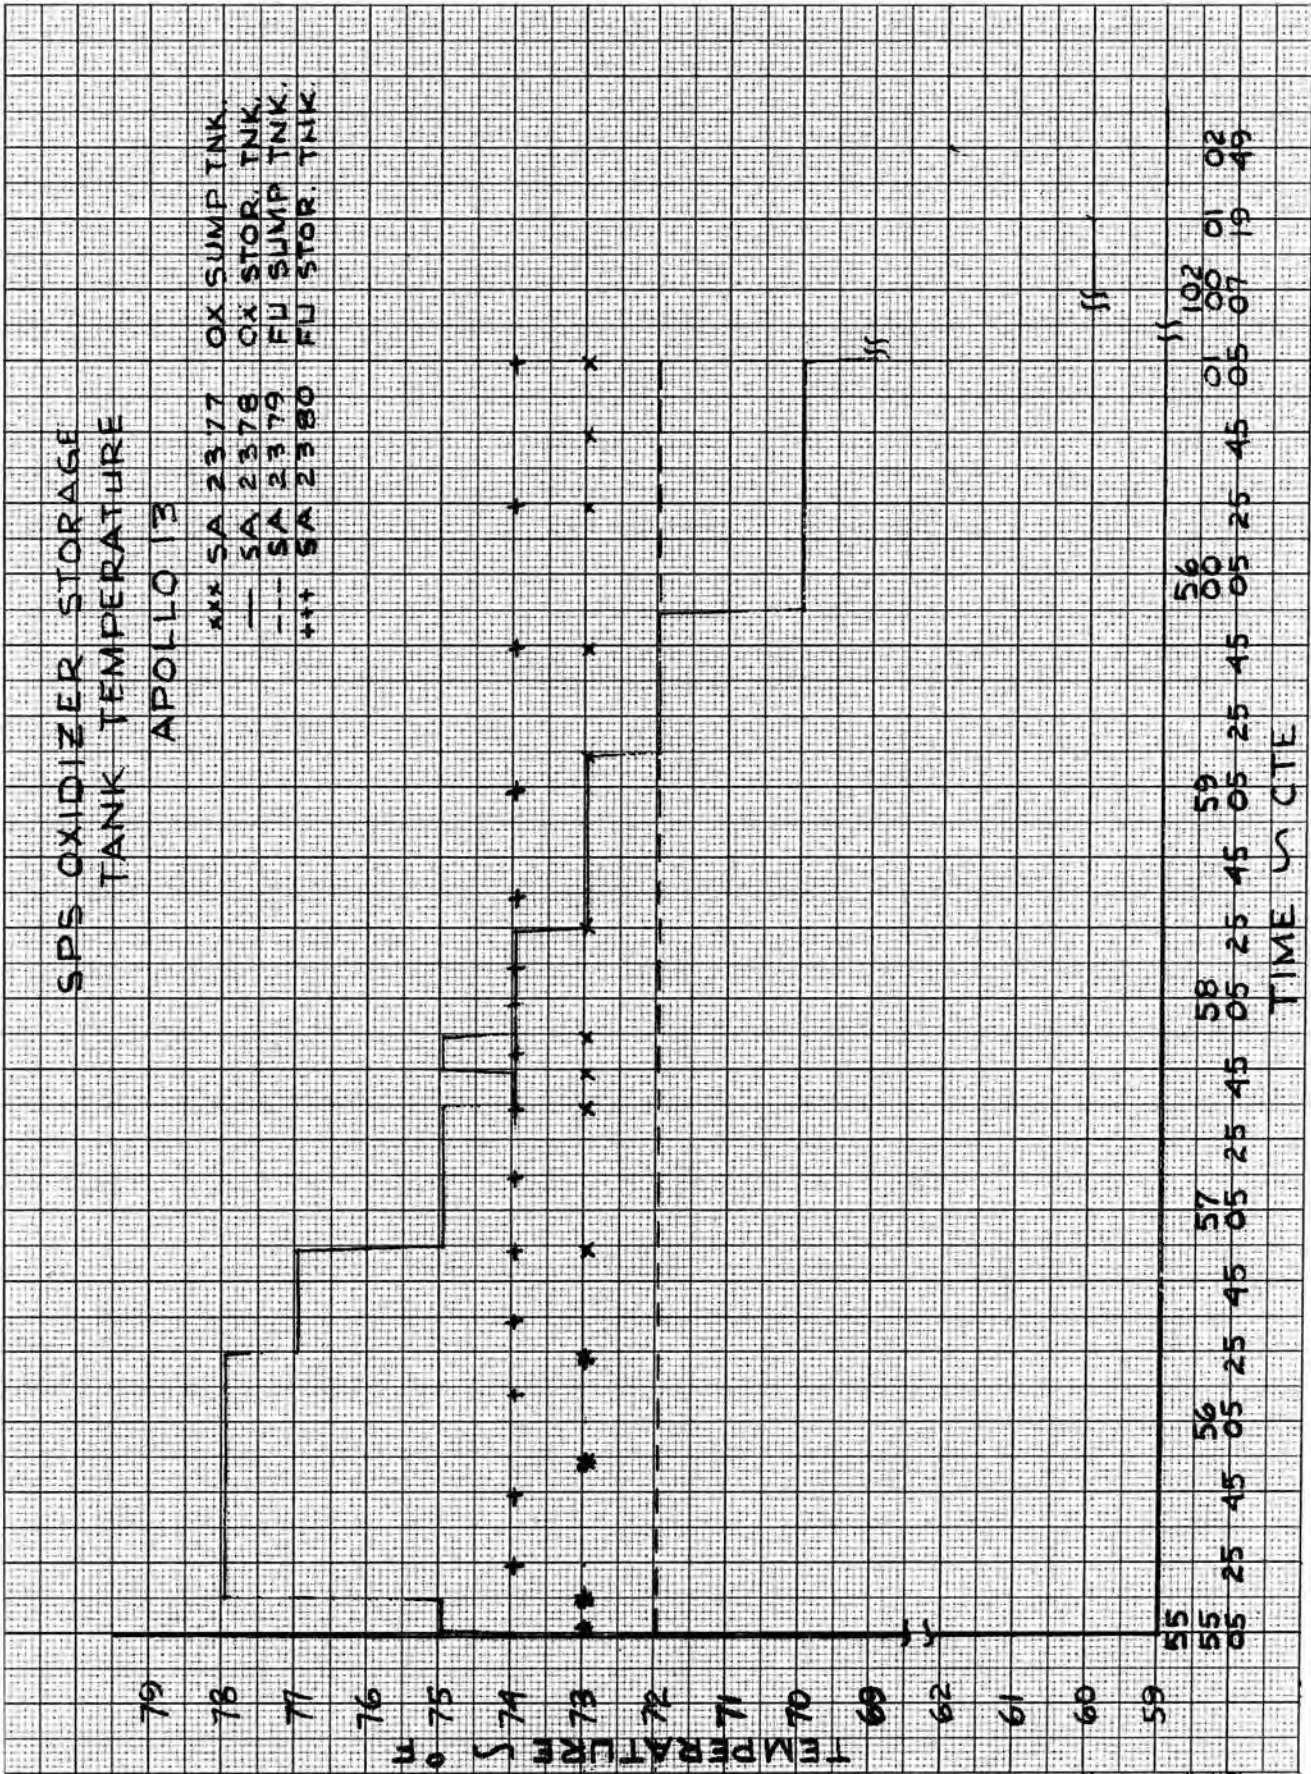
FIGURE 5

3. SPS - There were no SPS anomalies during this flight. Figure 5 is a plot of the propellant tank surface temperatures and shows an interesting but unexplained rise in the temperature sensor located in SM BAY 3. There is no data indicating damage to the SPS as a result of the O<sub>2</sub> tank fracture.

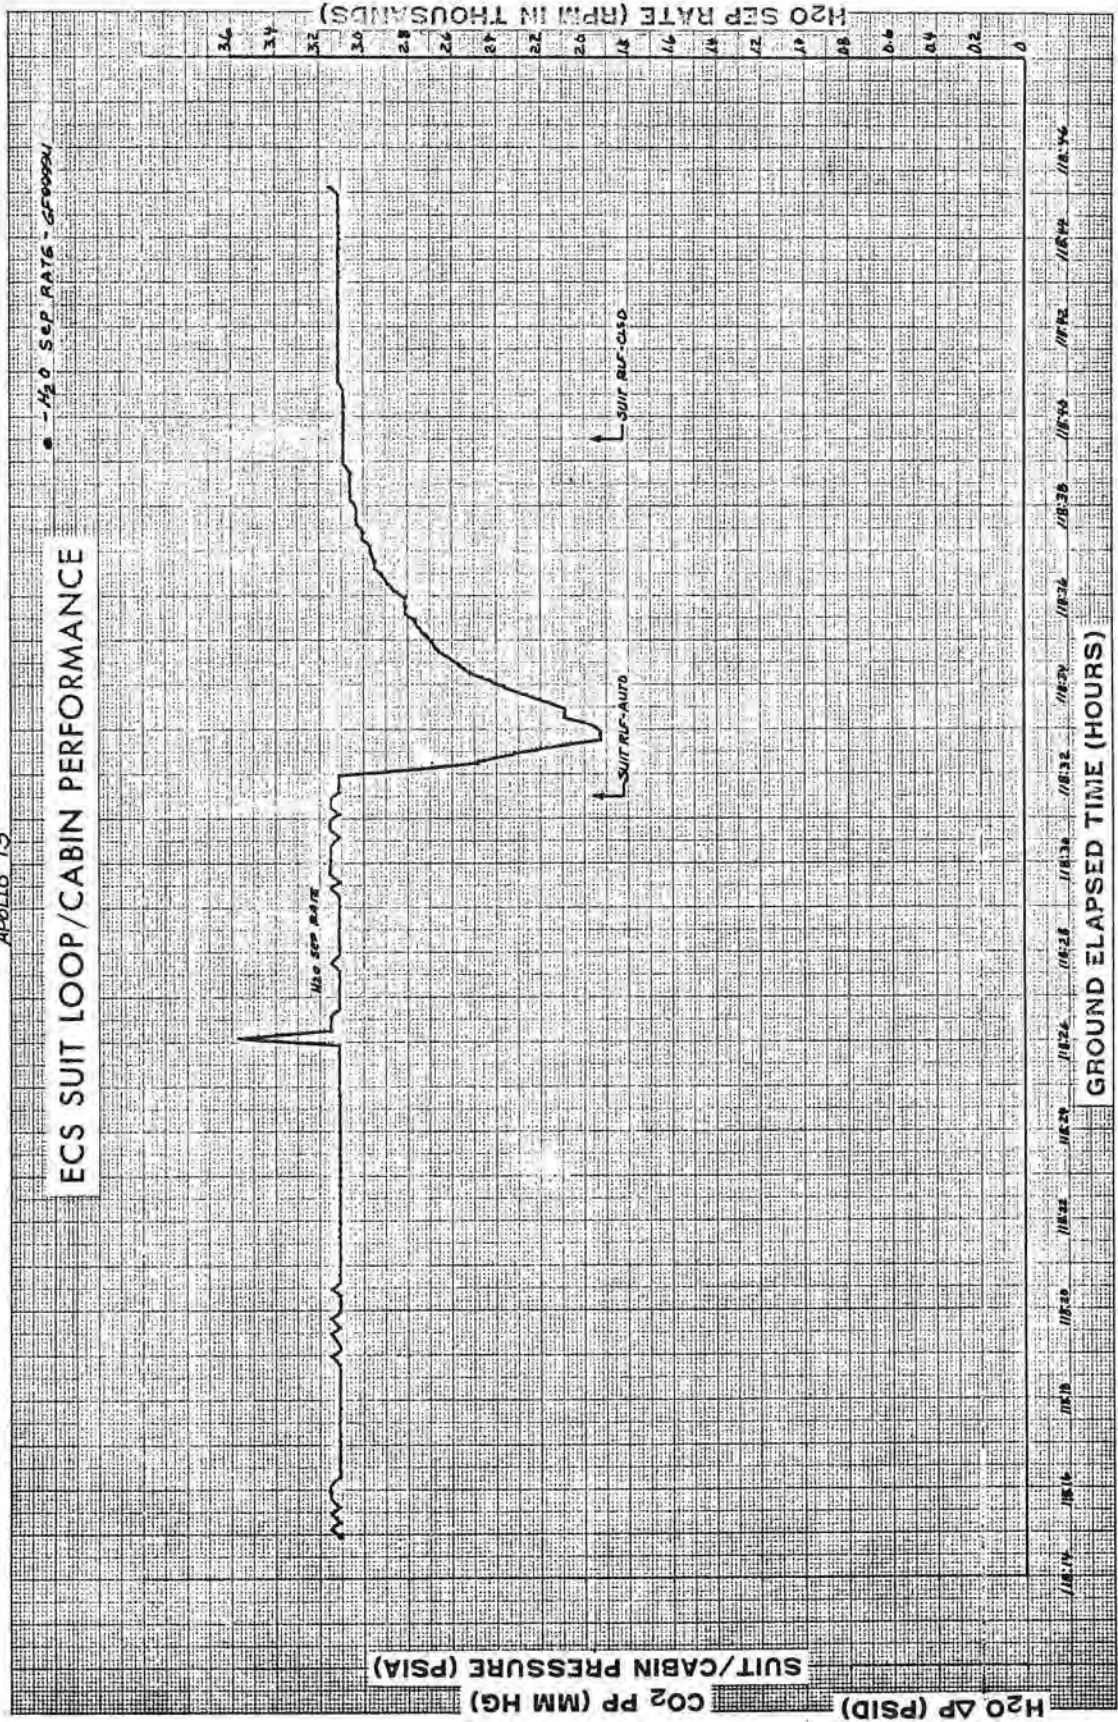
Figure 1-5

The expanded time scale plots indicate the effects of installation of the CM LiOH cartridge adaptors on the IM ECS hoses (Figure 1-4), an unexplained decay and recovery of the H<sub>2</sub>O separator (Figure 1-5), and a possible momentary battery, bus, or feeder short (Figures 9-1 to 9-5).

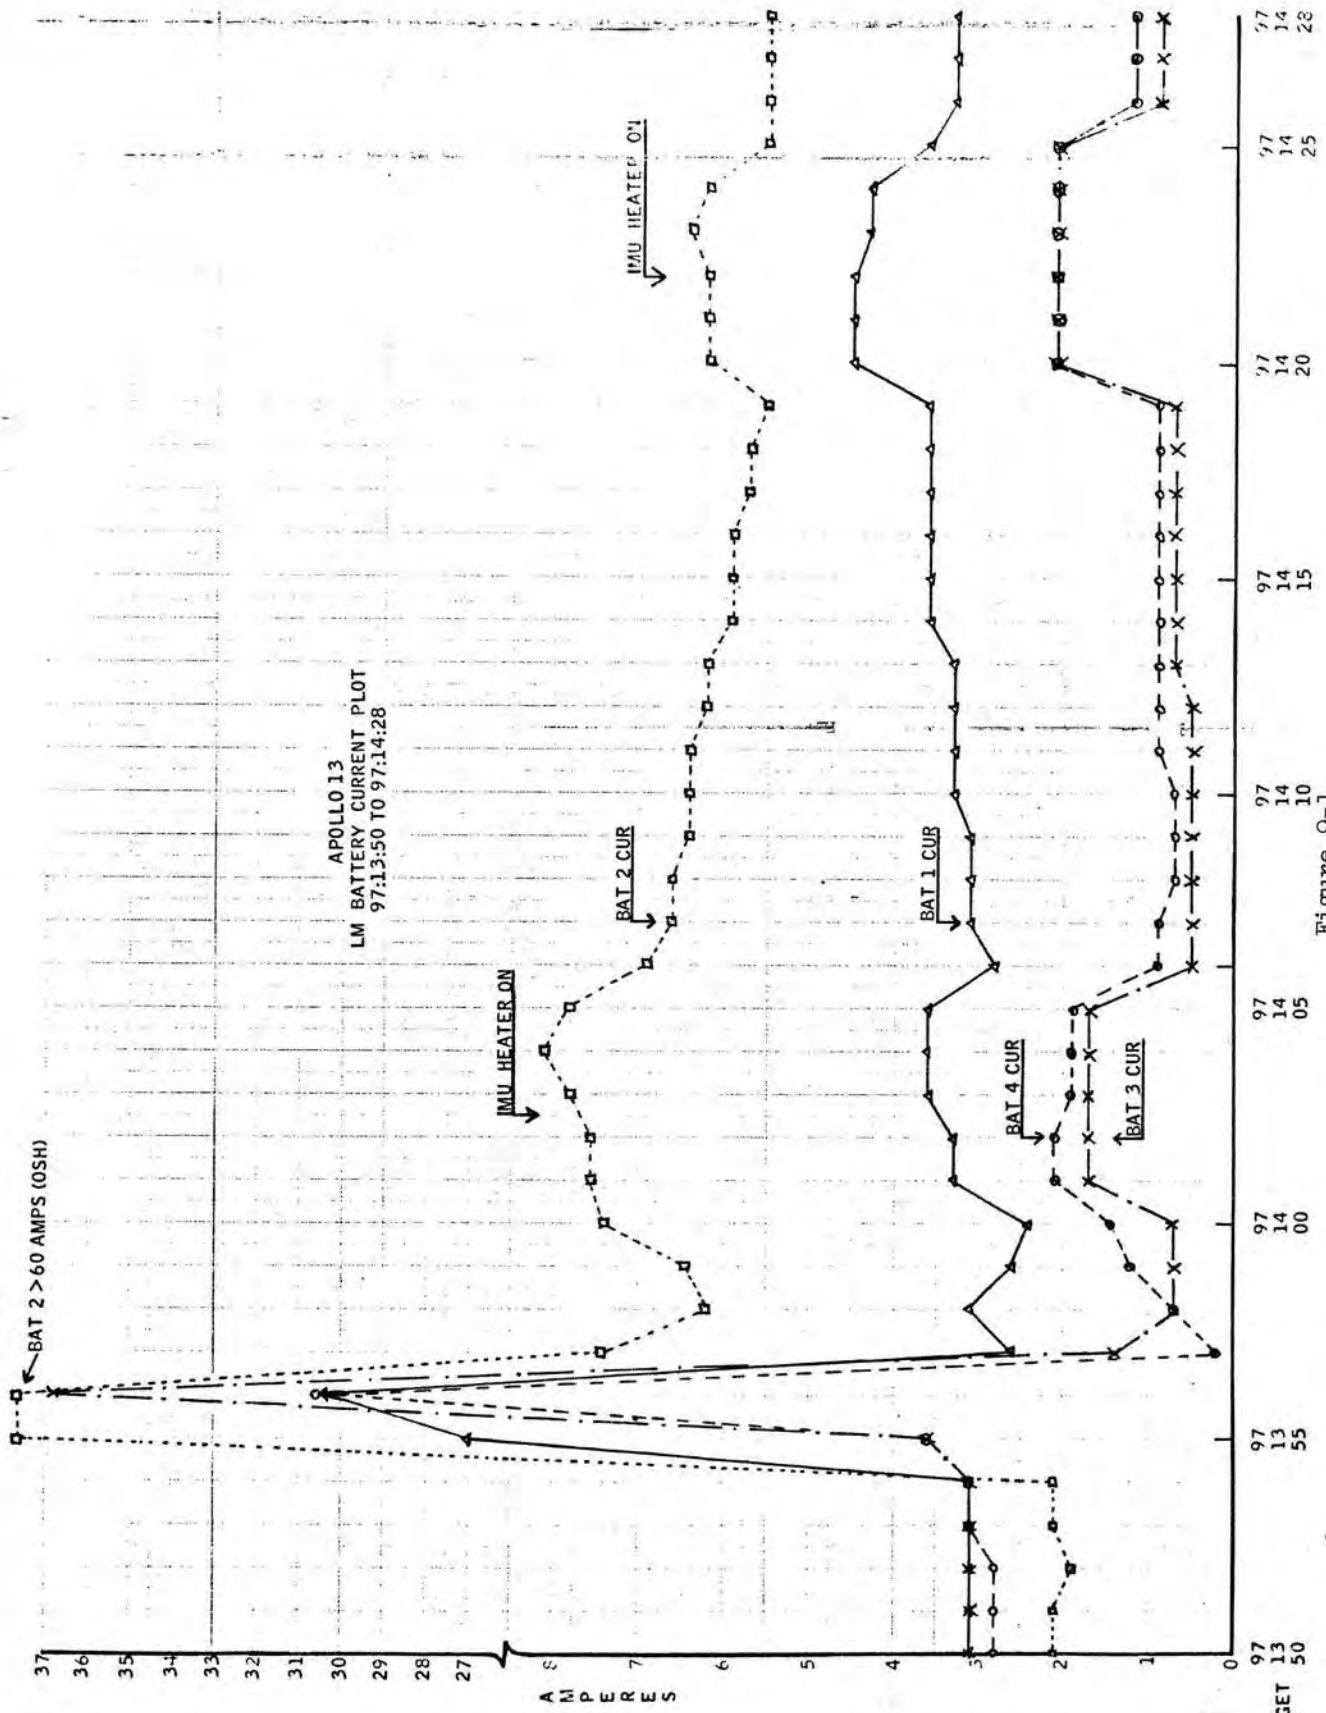
Figure 9-1

These data points are graphically depicted in Figures 9-1 through 9-4.

remained the same except during the two-second period. The load sharing may be noted in Figures 9-1 and 9-2.
