NATIONAL AERONAUTICS AND SPACE ADMINISTRATION

MISSION OPERATIONS REPORT

APOLLO 13

APRIL 28, 1970

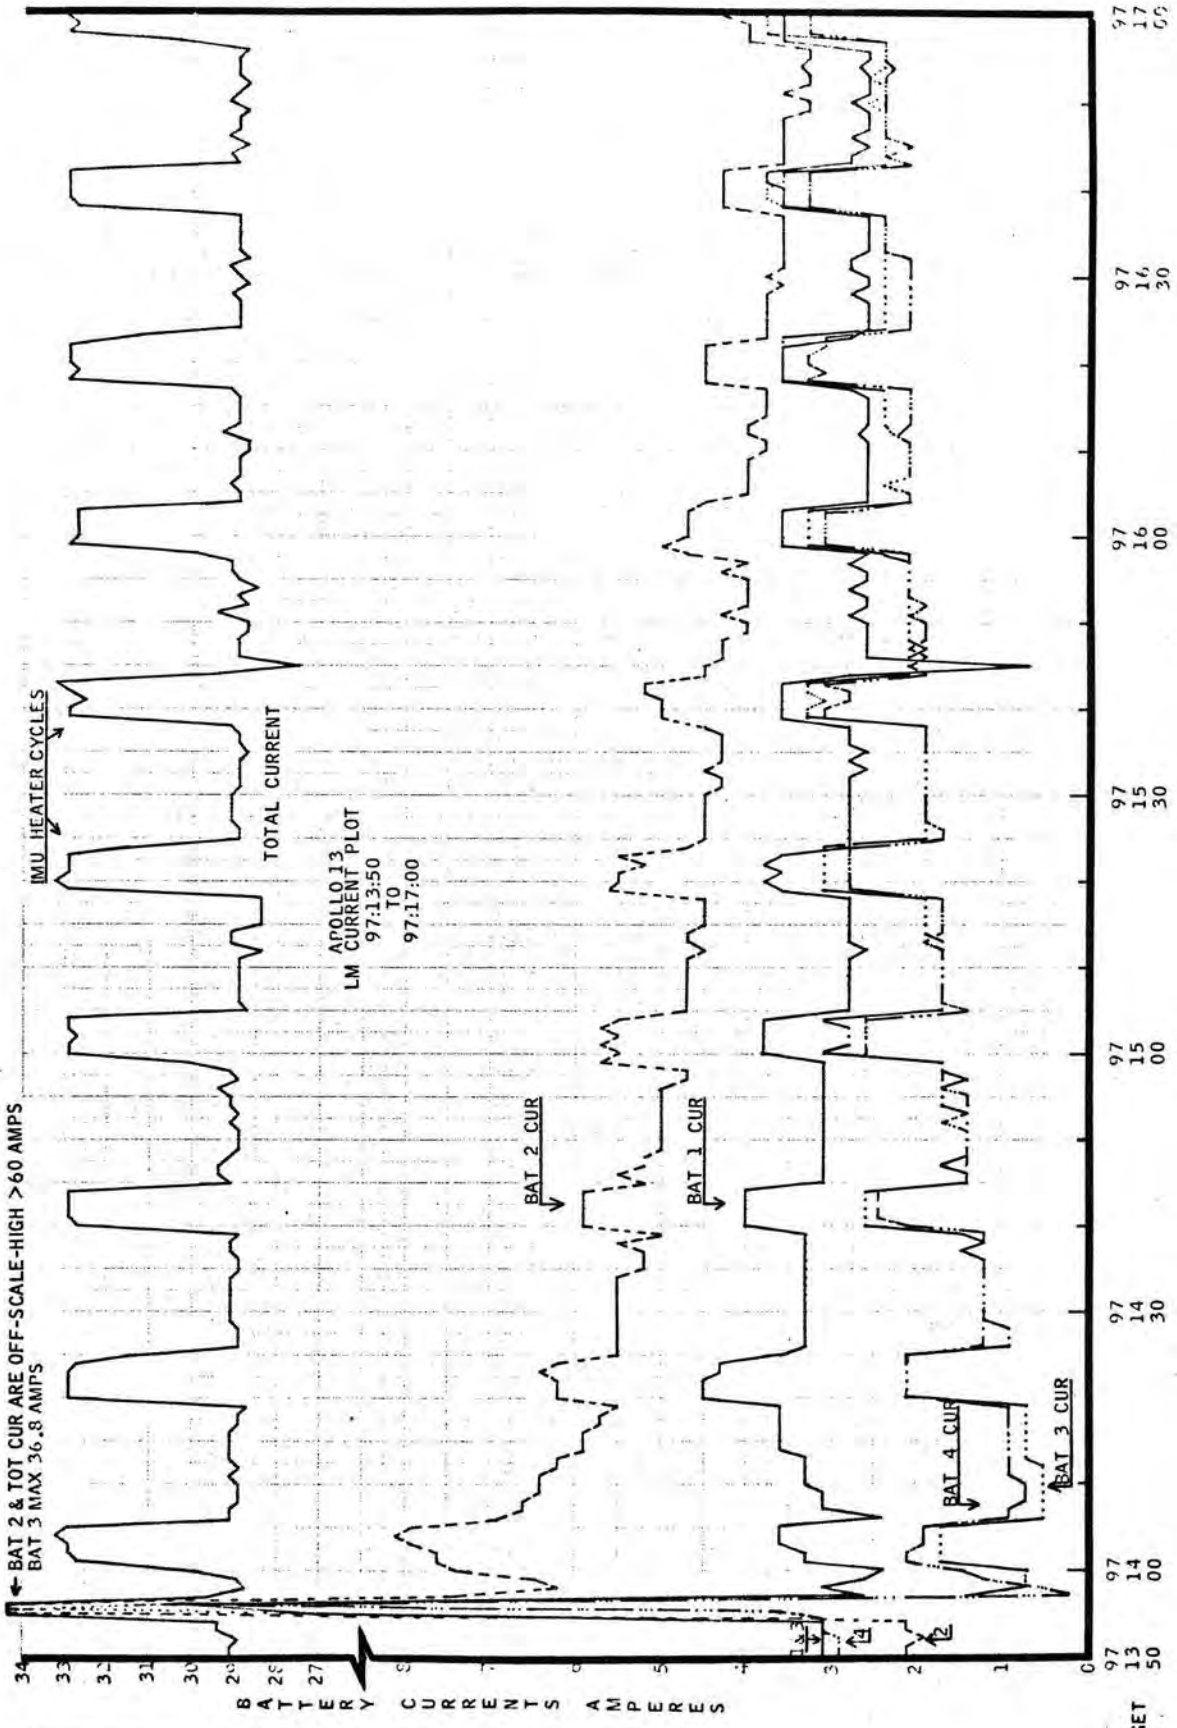
Figure 9-2

remained the same except during the two-second period. The load sharing may be noted in Figures 9-1 and 9-2.

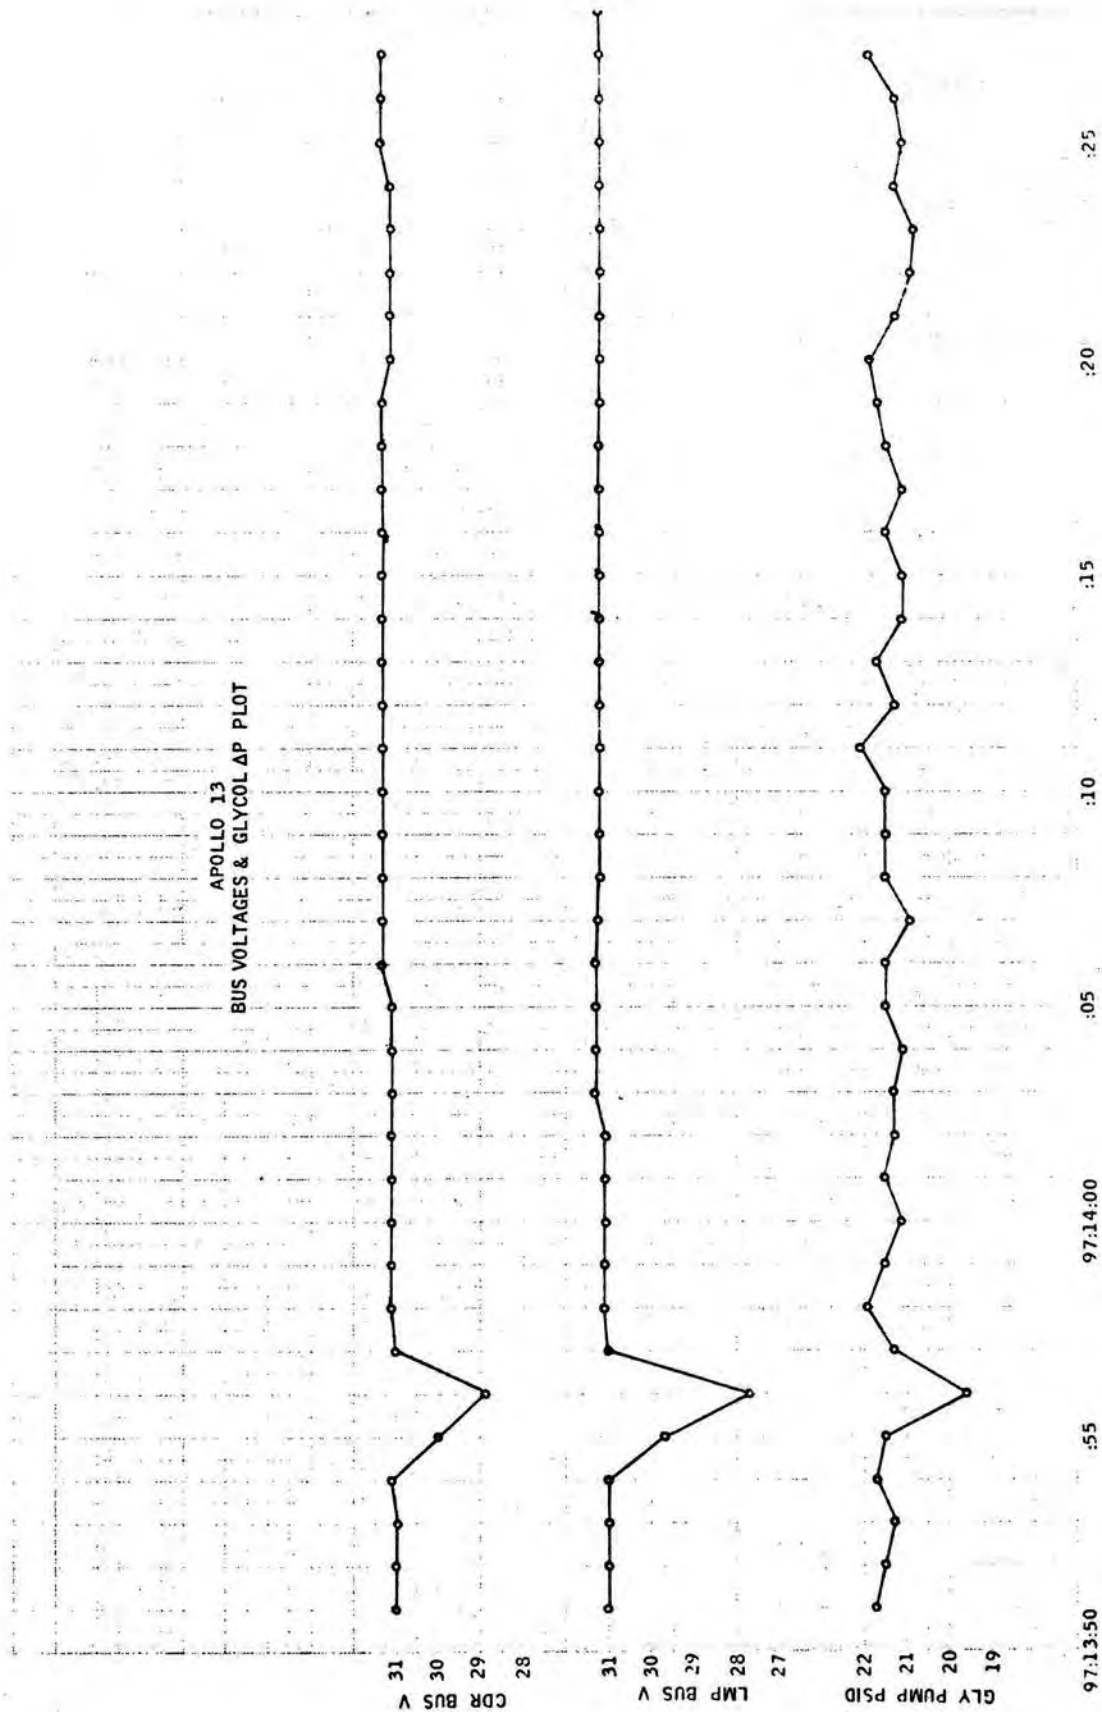
4. The glycol pumps have a history of being very voltage sensitive and the glycol pump  $\Delta P$  decreased coincident with the bus voltage drop (see Figure 9-3 for the bus voltages and glycol pump  $\Delta P$ ).

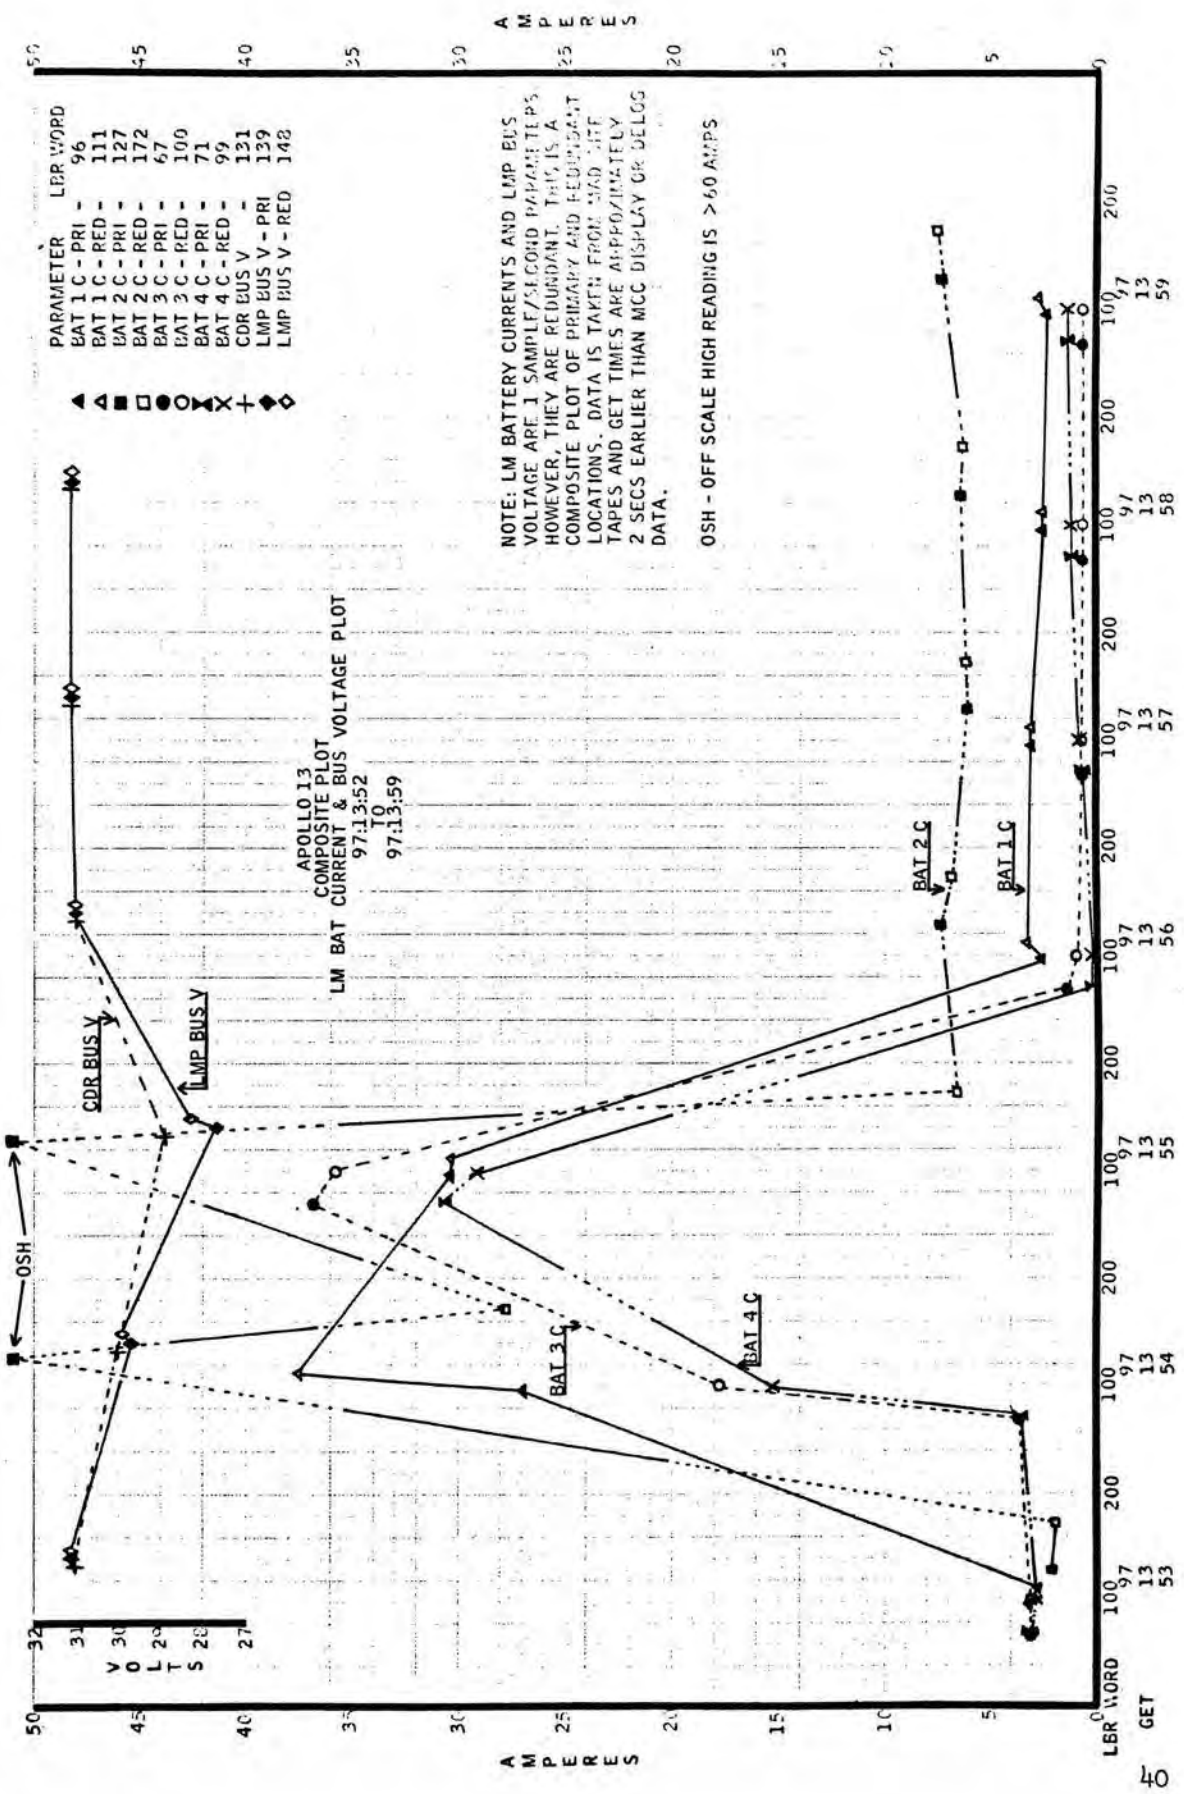
5. The four battery currents and the LMP bus voltage have redundant locations in the PCM bitstream and these points tend to corroborate the primary location data points (see Table 3 and Figure 9-4).

Special attention is called to battery 2 current readings on Figure 9-4, wherein the redundant location reading of 27.8 amps is bracketed by two off-scale high readings ( $>60$  amperes). At first glance, this reading appears to be inconsistent, and it might be dismissed as a bad data point since the other data points correlate to a single transient on all batteries. However, a closer examination of the LMP BUS voltage readings corroborates the battery 2 current readings and indicates a minimum of two transients.

While the data points are not adequate to confirm positively that the other three batteries did not go off-scale high for a very short period of time, the data points available point toward a reverse current condition in battery 2 with the other 3 batteries feeding a total current in excess of 90 amperes. This condition could occur if there had been a momentary switch to low voltage taps on battery 2, or shorted cells in battery 2. This theory could also be supported by the fact that no Battery MAL or Master Alarm indications were observed. A reverse current of 10 amps for  $5 \pm 1$  seconds is required to issue a battery MAL. Also, the bus voltages never dropped below 26.5 volts for more than 40 msec (reaction time of caution and warning) or C&W would have triggered a Master Alarm and a D. C. BUS warning. Probably the greatest single factor that supports the reverse current theory is the battery load sharing after the transients. An interesting correlation can be made between this incident and one that occurred during LTA-8 testing where large reverse currents were drawn by the batteries during switching between low to high voltage taps with the buses cross-tied. The battery currents and bus voltages are plotted versus time in Figure 9-5. As can be seen, the battery that drew the most reverse current for the longest time ended up carrying most of the load after switching was complete. Also battery 1 which drew no reverse current carried the least load when switching was complete. The other two batteries' sharing was related to the amount of reverse current that they carried.

All plots except for Figure 9-4 were made using RTCC processed data with IM display times, which are time tagged at the remoted site. This reference time is called LEMEGMT. Figure 9-4 was plotted using the Program Office bandpass printouts and the GET has been biased by a spacecraft-to-earth RF transmission time.

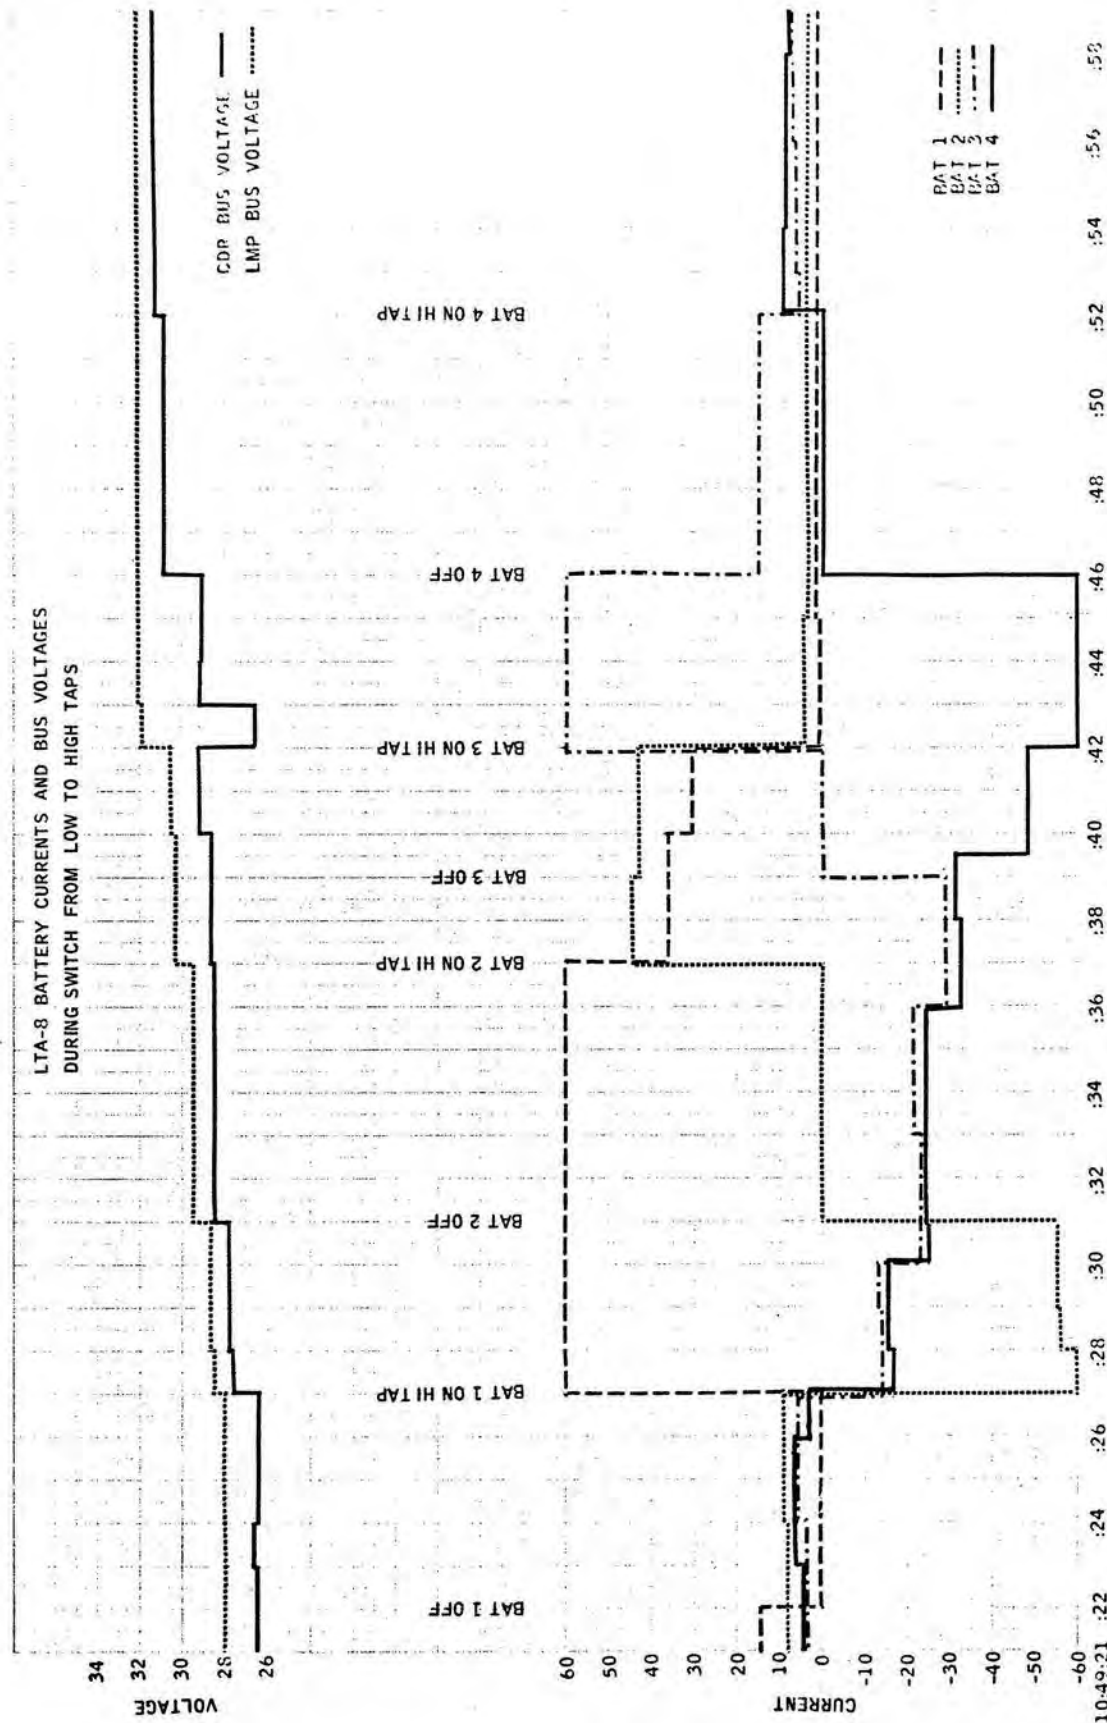
Figure 9-5

The expanded time scale plots indicate the effects of installation of the CM LiOH cartridge adaptors on the IM ECS hoses (Figure 1-4), an unexplained decay and recovery of the H<sub>2</sub>O separator (Figure 1-5), and a possible momentary battery, bus, or feeder short (Figures 9-1 to 9-5).
